REPORT

The Christmas Day landslide at Nottingham Castle

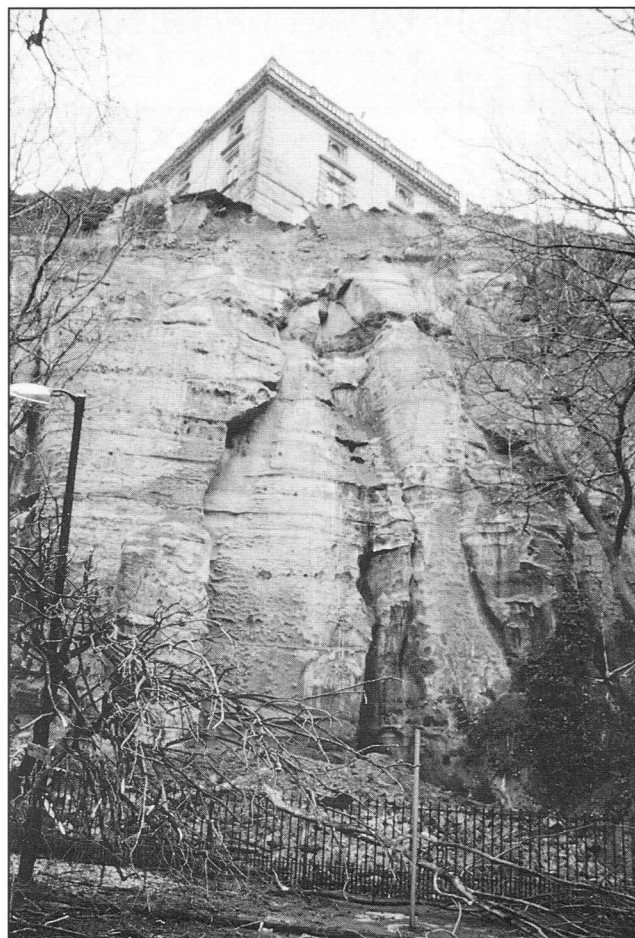
The site of the failure seen from the foot of the cliff on 27th December, before the loose debris was removed, and with the fallen tree and lamp post still leaning across Peveril Drive (photos by Tony Waltham).

The wall, the fill and the paving all fell to the foot of Castle Rock. Nearly 100 cubic metres of soil and masonry, weighing around 200 tons, lay piled on the strip of garden below. Most of it remained behind the iron fence, though the odd block of stone had bounced across Peveril Drive, where a sheet of sand and silt was also washed out. A plane tree was hit by the debris, so that it was laid across the road, where it bent a lamppost to a bizarre angle.

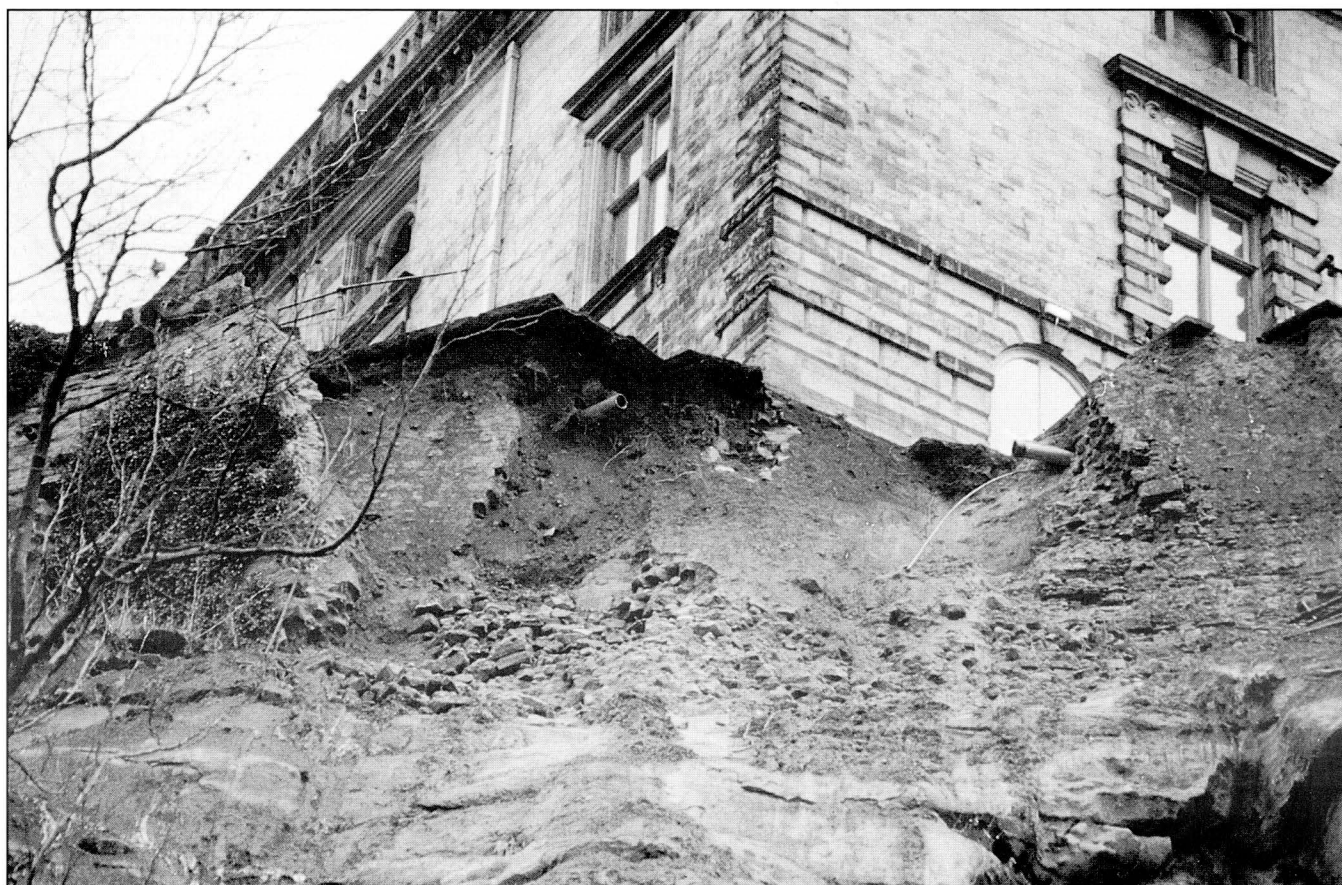
Up above, there was a yawning gap where about 10m of the wall had fallen away. With it had gone most of the soil and old masonry that had originally been held behind it. None of the bedrock sandstone had failed. The wall and artificial fill, and perhaps some remnants of natural soil, had merely slipped off the rock, with a slip surface at the rockhead. Fortunately the massive stone foundations of the Castle Museum had been built up from solid sandstone bedrock behind the rim of the steeper

Closer view of the slide scar, with the masonry of the Norman wall visible beneath the overhanging terrace paving; undisturbed sandstone is exposed at the foot of the picture.

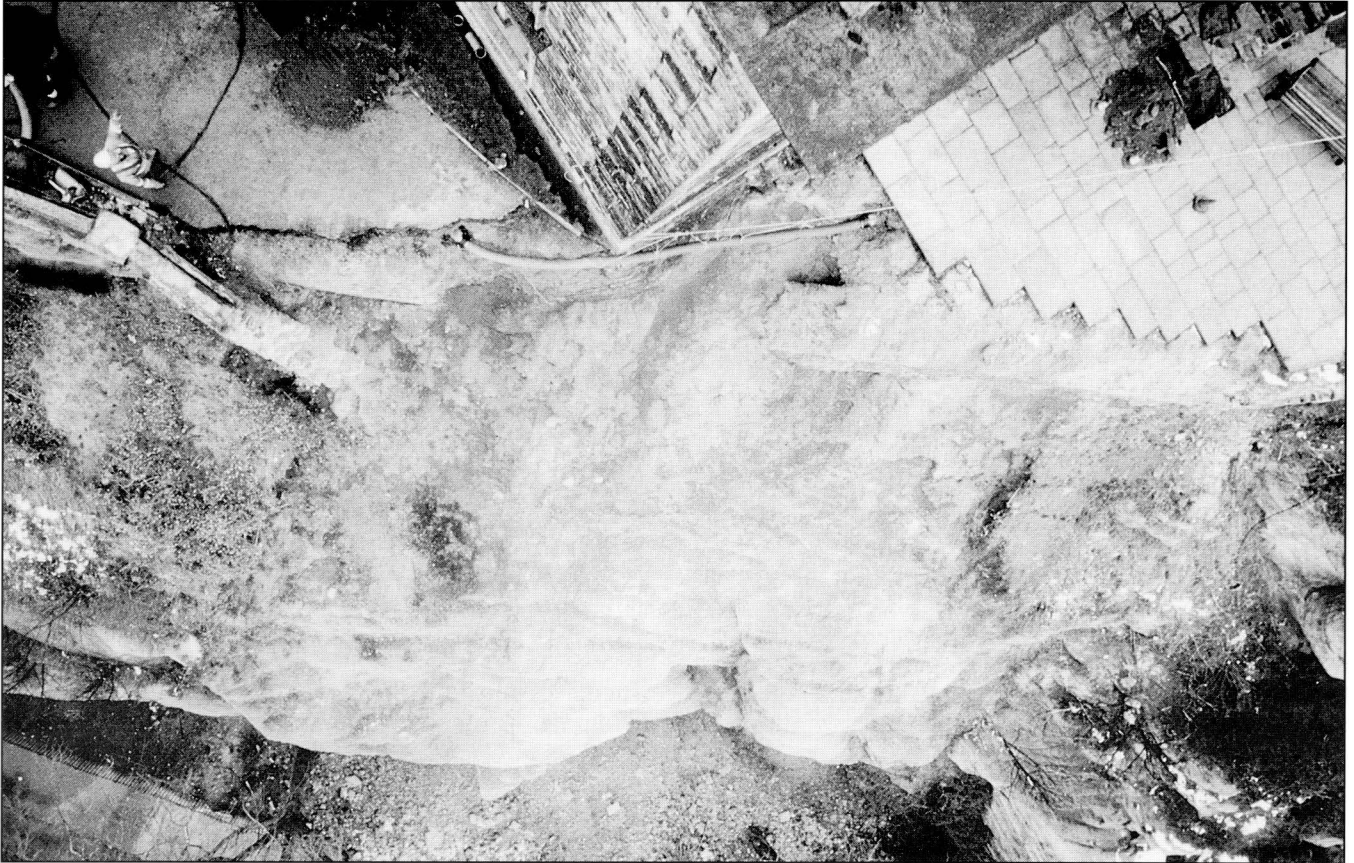
The landslide site seen from almost vertically above, after the loose debris had been cleared off. The straight line of the Norman wall is clearly exposed, as very little of it had fallen away; the gap in it dates almost entirely from about 1680, when space was created for the mansion foundations.

One incidental benefit of the landslide has been the exposure of a medieval wall, perhaps of Norman origin, which had lain buried under the paved terrace for over 250 years. A section of this was removed in about 1680, to make room for the foundations of the new mansion. A little more seems to have fallen away in the new landslide, but two cross sections through the rough sandstone stonework remain in either side of the slip scar. Repair work started in January. A temporary platform is supported on scaffolding columns which stand in vertical holes drilled a metre into the exposed sandstone. This working platform allows placement of rock anchors to tie the remaining walls and the museum foundations back to the sound sandstone. Designs for the renovated terrace have come down to two options. One has a new concrete wall, standing on and anchored to the exposed sandstone; behind it, a rubble or gravel fill re-buries the Norman wall, and carries the flagstone paving of a restored terrace. The concrete wall is faced with masonry blocks from the original wall, rescued from the debris below, so that the restored site will look as

before. Alternatively, the hole in the terrace is left open to expose the different foundations and wall remnants, now stabilised, and a cantilevered viewing platform will complete the terrace walkway by spanning the gap. Aesthetics and costs are the two factors which must determine the choice, hopefully to be made in time to complete the main works before the 1998 summer visitor season.

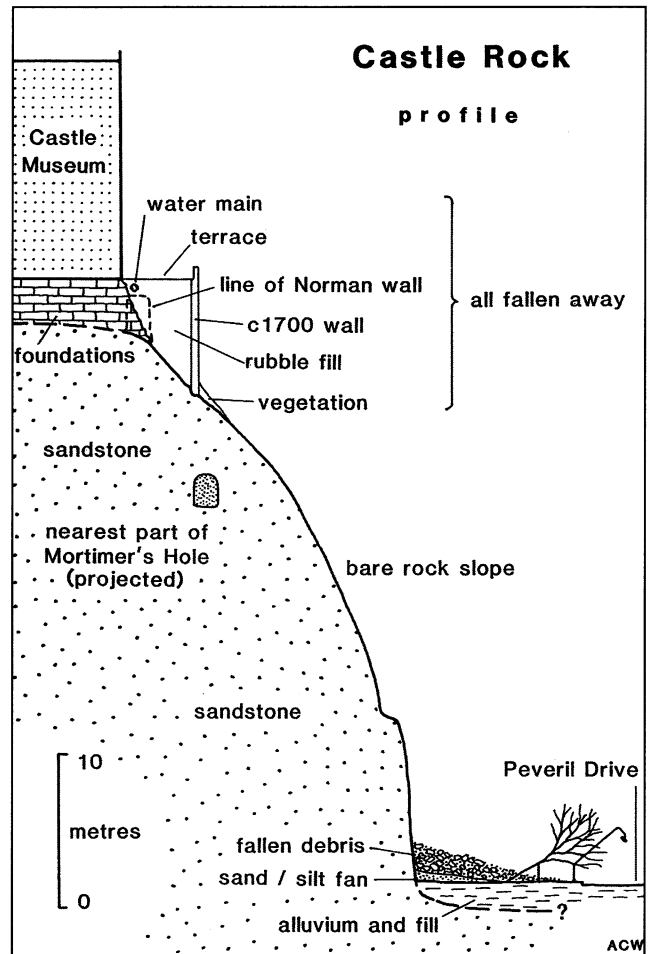
Profile of the southern end of Castle Rock, on the line of the 1996 landslide. The wall and terrace fill around the edge of the museum building fell away to expose the foundation, while the rock slope remained intact.
