Fault Reactivation Induced by Mining in the East Midlands

Laurance J. Donnelly

Abstract: Mining-induced fault reactivation has been observed at several localities throughout the East Midlands, between 1930 and 2000. The generation of new fault scarps has caused widespread damage to structures and land. These scarps are distinct, reach over a metre high and extend for several hundreds of metres at outcrop. In areas of moderate relief, such as on the Permo-Triassic escarpments, natural process of cambering and valley bulging may be exacerbated by mining subsidence. Recent field observations suggest that some faults may undergo renewed phases of reactivation, several years after mining has been abandoned, probably due to minewater rebound, although this is difficult to prove at some sites. Some of the engineering problems and environmental geohazards associated with fault reactivation are outlined with reference to case examples.

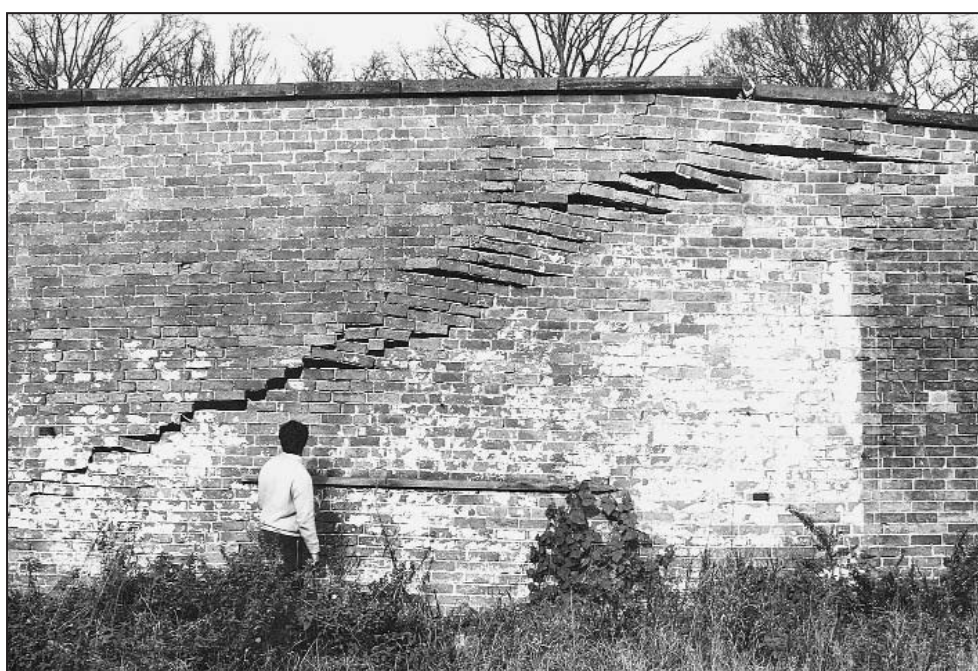
Fault scarps caused by mining subsidence are often described by subsidence engineers, as steps in the subsidence profile or 'break-lines' along the ground surface (Fig. 1). In the East Midlands, these have damaged civil-engineered structures, residential houses, industrial premises, roads, motorways and railways. Movement along faults has also effected underground utilities such as gas and water mains,

Figure 1. Reactivation of a fault generated a 0.3m high fault scarp and caused severe damage to a 5m high brick wall at Eastwood Hall. The date of reactivation is not known, but was probably in the 1960s. This section of wall has been demolished, but evidence of further fault reactivation was visible on an opposing wall in May 2000.

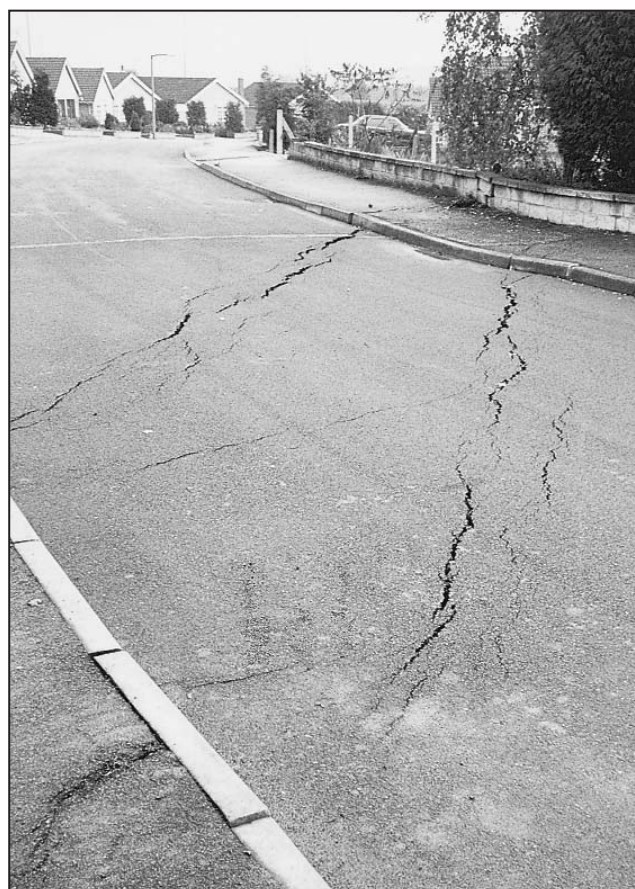
The earliest records of fault reactivation were during the working of the Deep Hard seam in the 1950s, at depths of around 28m below Inkersall. Further phases of reactivation occurred in 1985, during the working of the Piper seam, at about 300m depth, from Markham colliery. This created surface movements that caused severe damage to property in the Inkersall Green housing estate, and generated fault scarps (Fig. 3) that were locally over 1.5m high. Eight houses (Fig. 2) were severely

Figure 3. Reactivation of the Inkersall Fault in the 1980s, caused widespread damage at the northern end of the Inkersall Green housing estate; this small graben feature formed across a road over a subsidiary fault within the Inkersall fault zone.

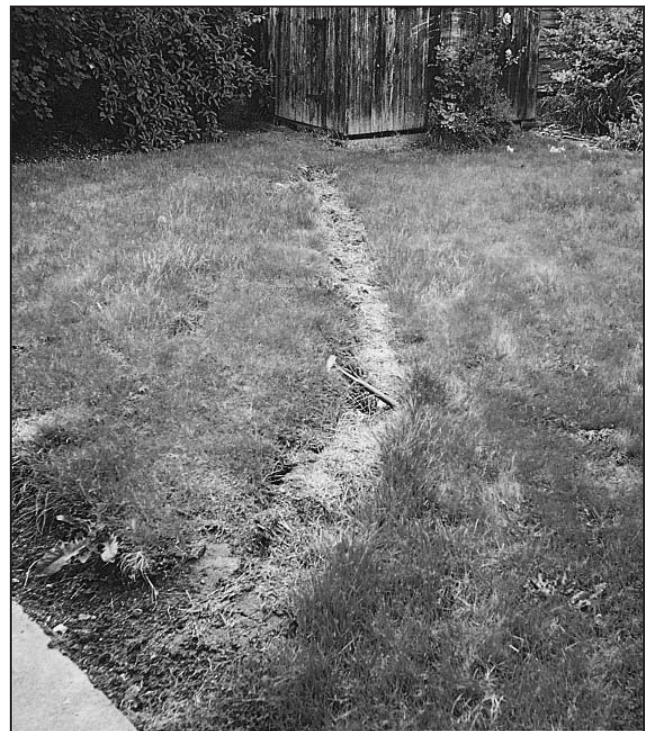
In 1991, following reports of further movements along the fault and renewed structural damage to the school and houses in Inkersall Green (Fig. 5), two monitoring lines were established. These were set across the fault along Inkersall Road and Inkersall Green Road and were surveyed regularly from

Figure 5. A scarp within the Inkersall fault zone during the early 1990s phase of reactivation, in the back garden of a house at Inkersall Green.

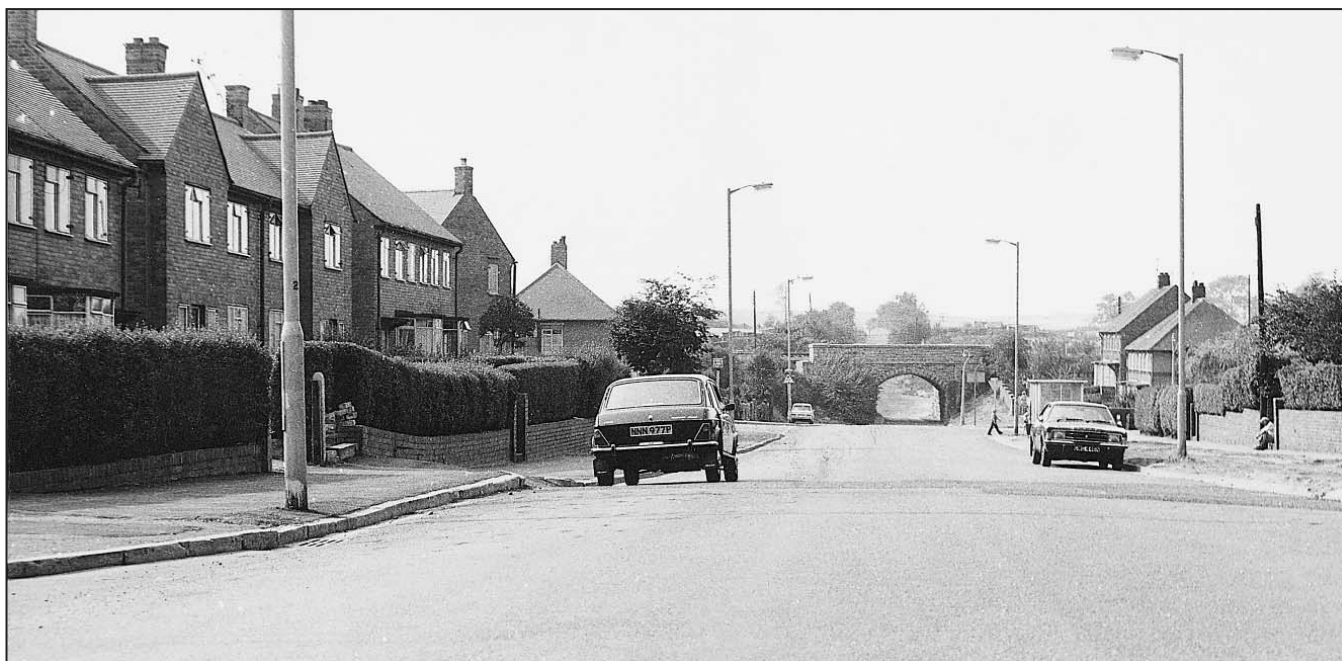
In 1976, a fault scarp 1m high developed across Vale Road (Fig. 6), causing severe damage to the road, pavements, walls and neighbouring houses. Photographic evidence of repairs to the road surfaces implies that several phases of reactivation may have occurred. This is not uncommon, as faults are capable of multiple phases of reactivation, during mining of three or more seams, separated by periods

Figure 6. Reactivation of a fault in 1976, generated a scarp 0.5m high that caused moderate damage to Vale Road, Mansfield.

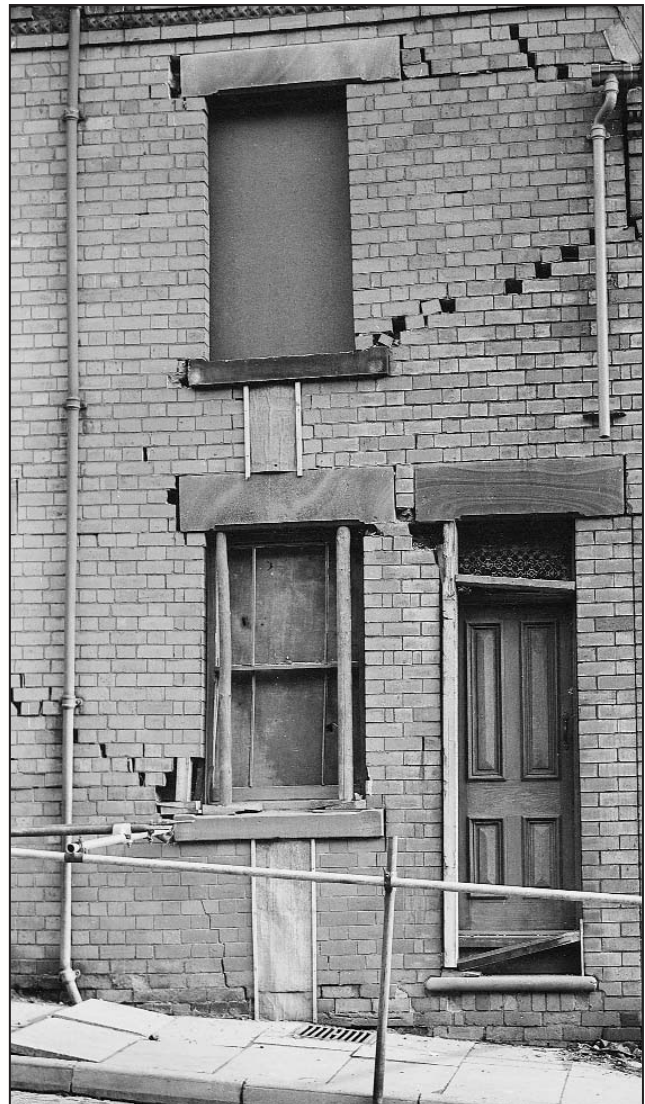
Individual houses in the two long terraces down Belvoir Street were severely damaged when they were undermined in 1955 (Fig. 7). The site is on the outcrop of the Magnesian Limestone, and the damaged houses appear to lie above a few major fissures. The houses on each side along the terraces suffered only minimal movements, as they stood on stable blocks of limestone. The damaged houses had to be completely rebuilt, but subsequent mining of deeper seams caused renewed movement and repeated damage on a lesser scale to the same houses. Mining has now ceased and there has been no recent movement.

Figure 7. Damage to a terraced house in Belvoir Street, Hucknall, in 1955. The house has since been rebuilt.

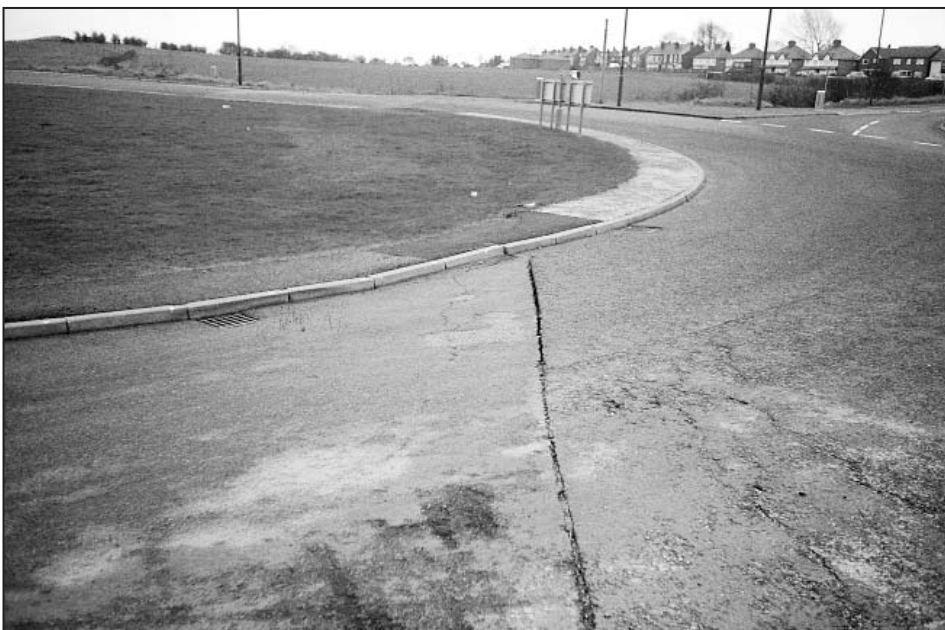
In 1992, a graben about 60m long and 1.5m wide, was accompanied by subsidiary scarps, compression humps and en-echelon fissures across the roundabout on the A610 outside the police headquarters. The date when the scarps first appeared is not known, but their growth has caused visible damage to the road surfaces, roundabout, pavement, grass verges and fields almost continuously until the present day. The main scarp is currently marked by a low east-facing step in the road surface (Fig. 8), whose frequent repairs cause temporary traffic delays. There is no current mining beneath the site, and the continuing deformation of the ground is not fully understood.

Figure 8. The latest in a series of fault reactivation phases, from 1991 to 2000, causing moderate to severe damage to the A610 bypass at Ripley.

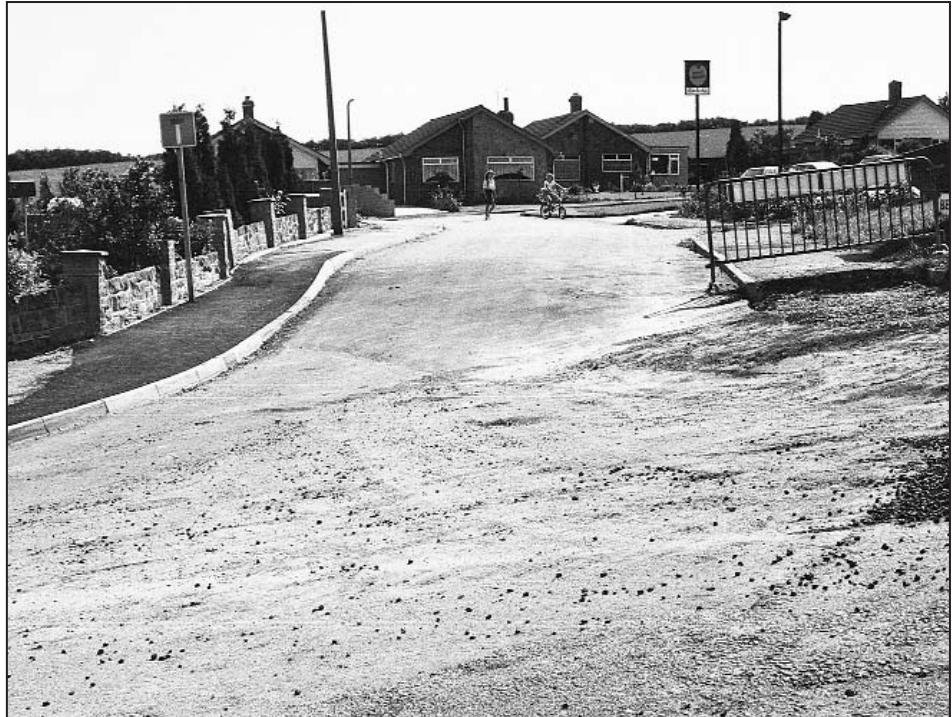
Figure 9. A fault scarp across a road in a housing estate at Inkersall, near Chesterfield, has reactivated as successive coal seams have been mined from beneath, causing repeated damage to the road and adjacent houses.

The purpose of this paper has been to draw attention to some effects of fault reactivation in the East Midlands, as a consequence of underground coal mining. These faults have generated distinct and occasionally extensive scarps across the ground surface, and have caused widespread damage to structures, utilities and land (Fig. 9). The scarps tend to be temporary features of the landscape, and
