GEOLOGICAL INVESTIGATION OF SITES FOR A PROPOSED M42/M1
MOTORWAY BRIDGE CROSSING, NEAR STANTON-BY-DALE, DERBYSHIRE

D. S. Buist and F. M. Taylor

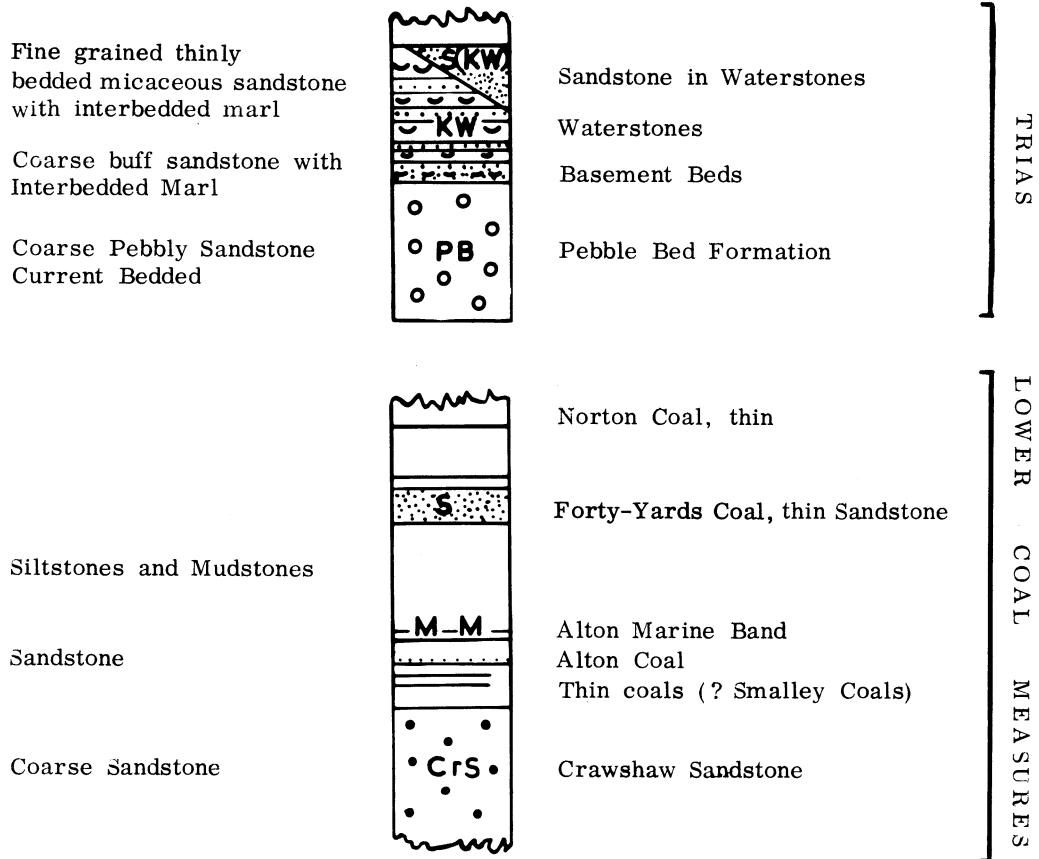
Text-fig. 2. Generalised Vertical Section

Text-fig. 1 is a reduction from the completed 1/2500 plan and indicates the geology of the area and the position of two possible bridge sites; the first, situated north of the major fault, is entirely underlain by Coal Measures strata and the second one, currently under consideration, is on Permo-Triassic rocks. Text-fig. 2 summarises the rocks found in the area.

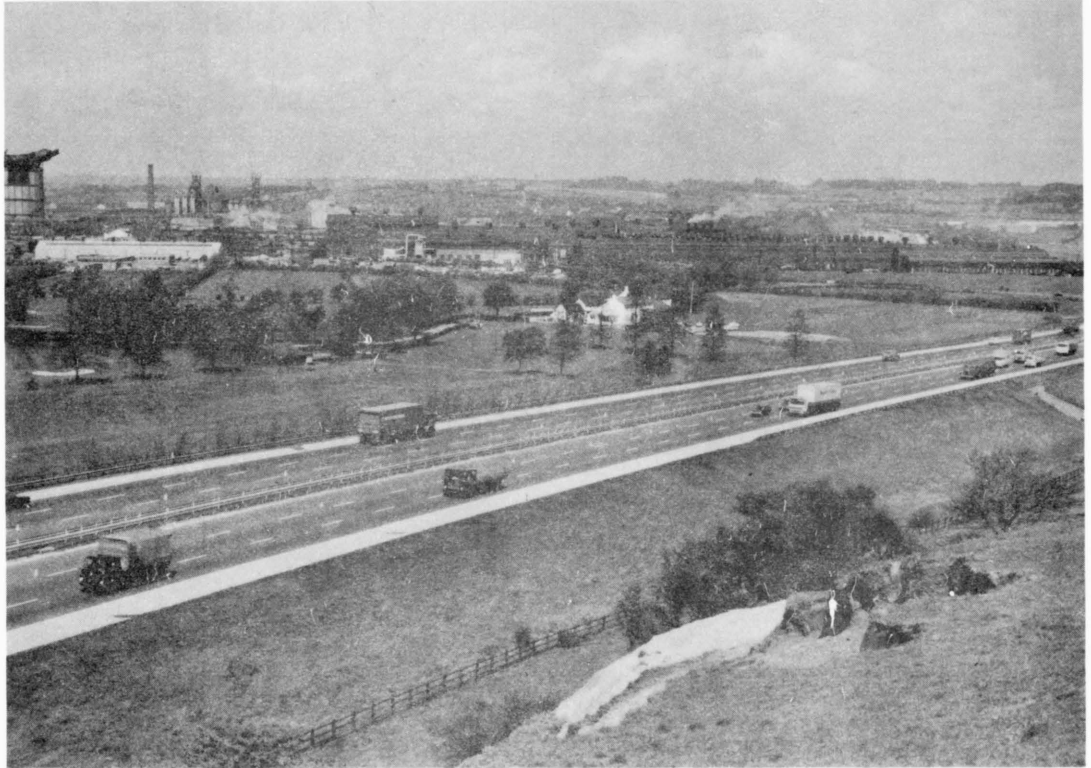
Fig. 1. First Bridge site.

Thus, although the general geology of the area indicated initially that a possible site occurred at this point, the subsequent detailed investigation proved that foundation engineering would be complex. There would be not only the risk of constant flooding of the site but also of failure to locate consistently competent strata on which to build the bridge foundations. A second site, some 300 m to the south-west, was therefore investigated.

fig.1. General site area of M42/M1 first bridge site, taken from Stony Clouds (outcrop of Lower Triassic Pebble Beds in the foreground). The M1 motorway is in the centre of the photograph with the Erewash Golf Course, Club House and Stanton Iron Works beyond. The motorway underpass can be seen on the far right of the fig.

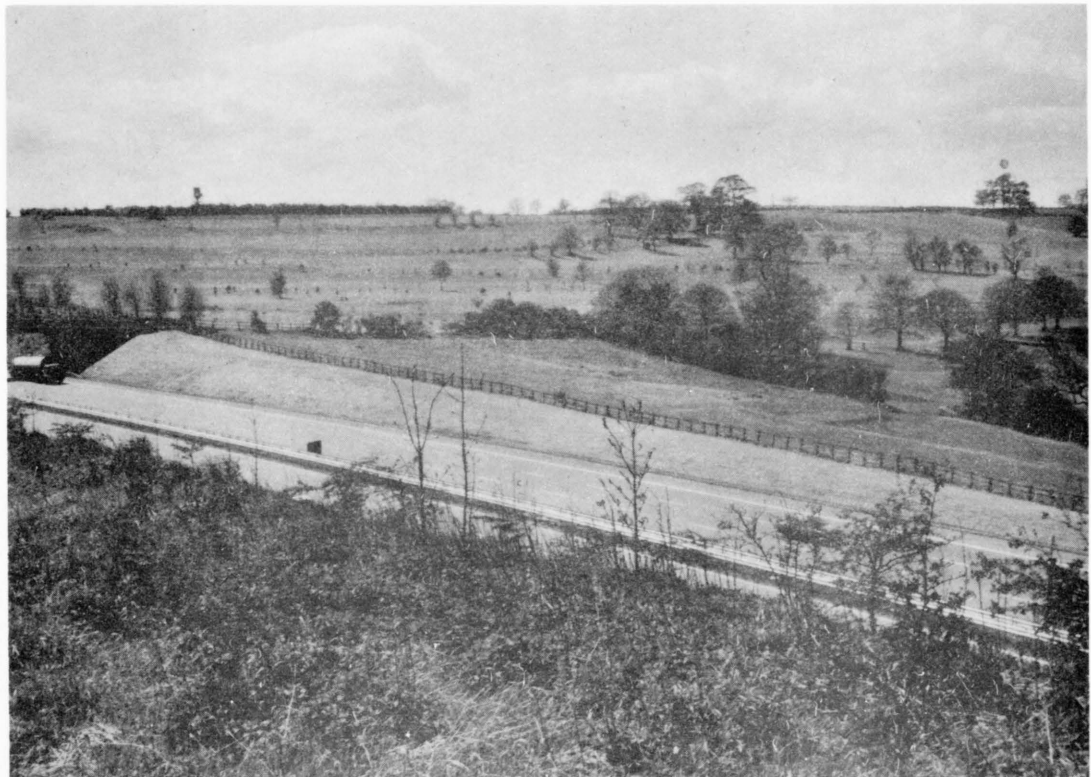
Fig. 2. Second Bridge Site.

The sandstones should form excellent strata for all the foundations of the M42 bridge and the Waterstones Formation below, consisting of thin sandstones and marls, would also be suitable. If necessary the foundations could go deeper to the level of the Pebble Beds but, as the higher rocks are unweathered, the deeper foundations are unnecessary. There were no faults recorded from the area outlined on text-fig. 1 as the second bridge site, and there were no water problems.

fig.2. General site area of the M42/M1 second bridge site as proposed, to be sited to the right of the footbridge. Taken from Stony Clouds with the Erewash Golf Course beyond the M1 motorway cutting.

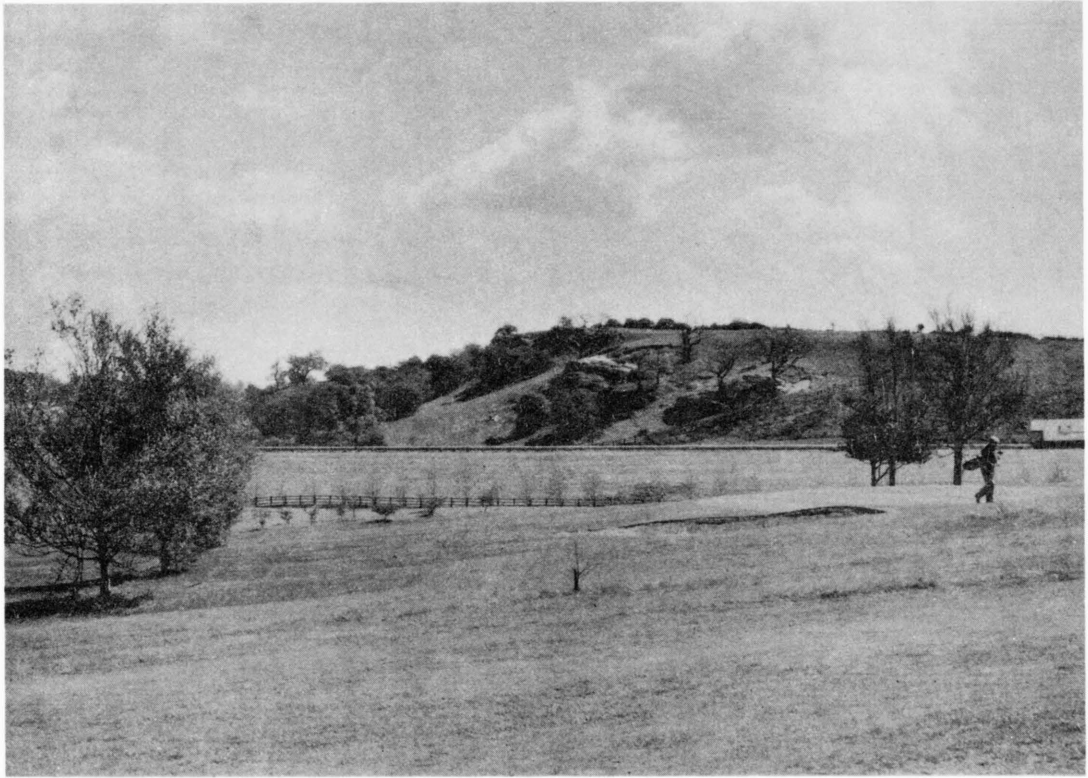
Fig. 1. Stony Clouds, Sandiacre.

fig.1. Stony Cloud outcrop of Pebble Beds from the Erewash Golf Course, looking east. The escarpment is controlled by a fault separating the Pebble Beds from Upper Carboniferous Rocks.

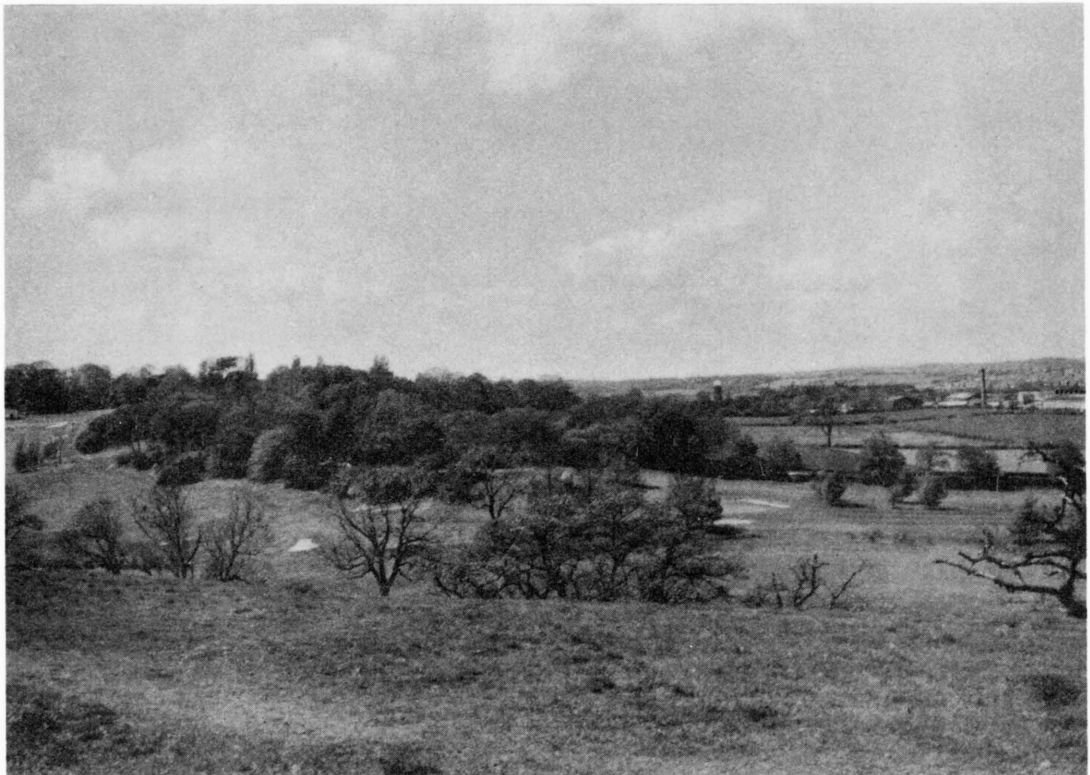
Fig. 2. Crawshaw Sandstone Outcrop, Stanton-by-Dale.

fig.2. View from Stony Clouds looking approximately west. The thick belt of trees marks the position of the old quarry in the the Crawshaw Sandstone.
