## THE BRETTON CLOUGH LANDSLIDES, DERBYSHIRE

A D Boggett

Mercian Geologist, Vol. 11, no. 4,  
1989, pp. 223–235 plus  
3 pages of plates.

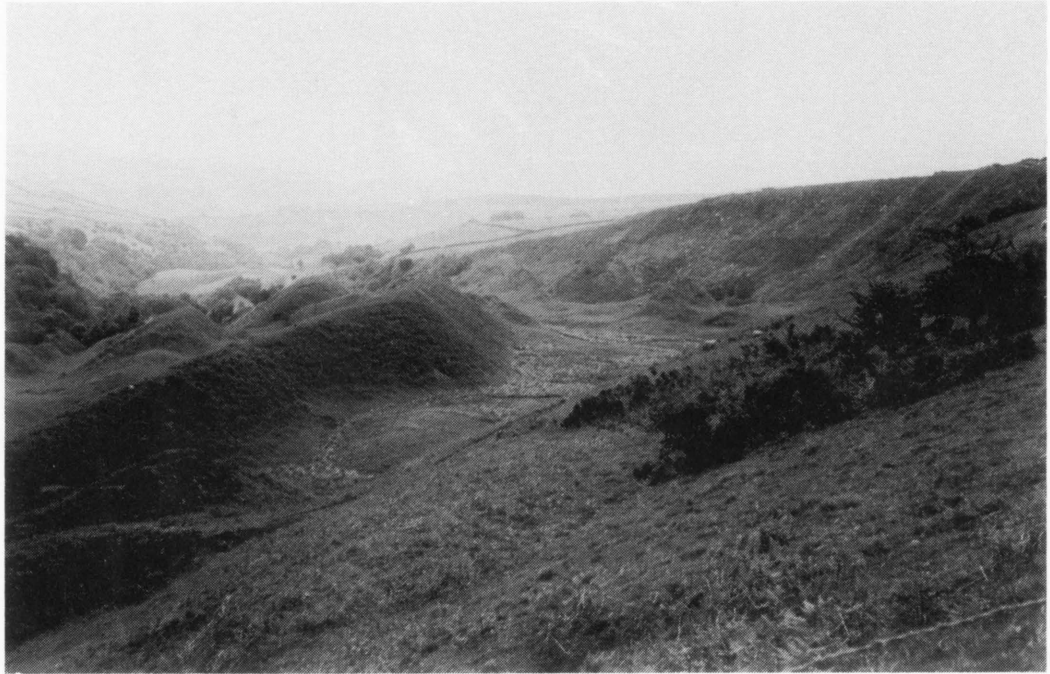
Plate 1. The most westerly landslide in Bretton Clough. Different geomorphological units are clearly visible, that of the scar, area between scar and slide blocks, and the slide blocks.

From the maps, the landslips can be divided into distinct geomorphological units, (i) the scar, (ii) the area between the scar and slide blocks, (iii) the slide blocks and (iv) the toe/river cliff (see Fig. 6 and Plate 1).

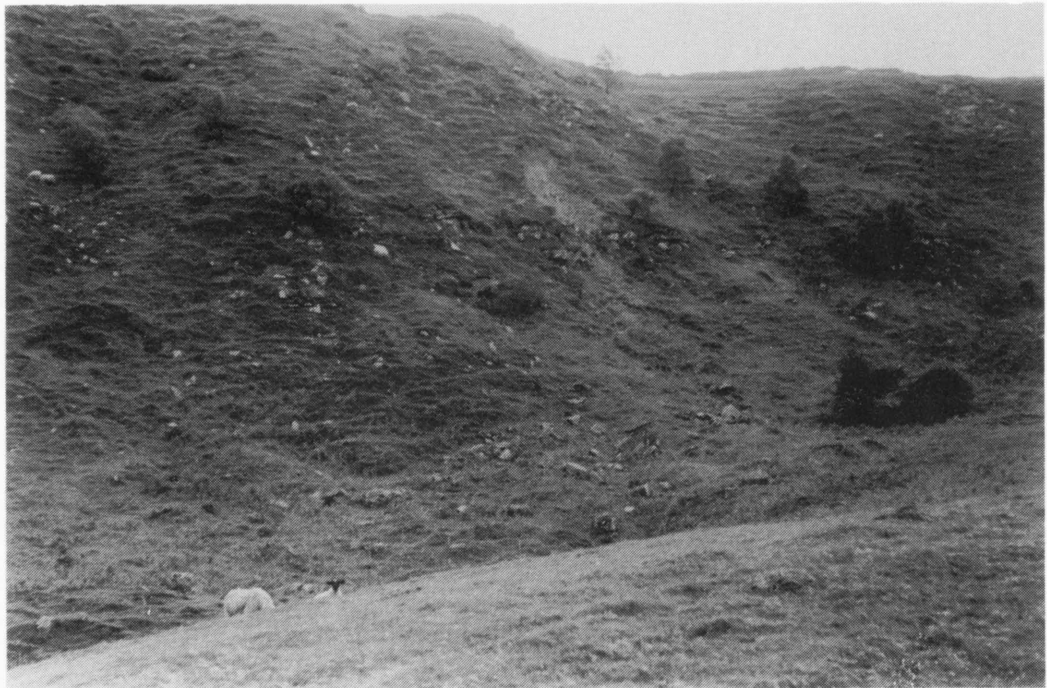
Plate 2. A section of the scar of the most westerly landslip. The midslope terrace feature is non-existent at this locality. The debris slope is visible along the lower half of the scar (from SK 19537828).

There are three distinct landslide scar areas along Bretton Clough. These are at: SK 191781–199785 (see Plate 2), SK 200785–204784 and SK 206784–209787. The scars comprise four units.

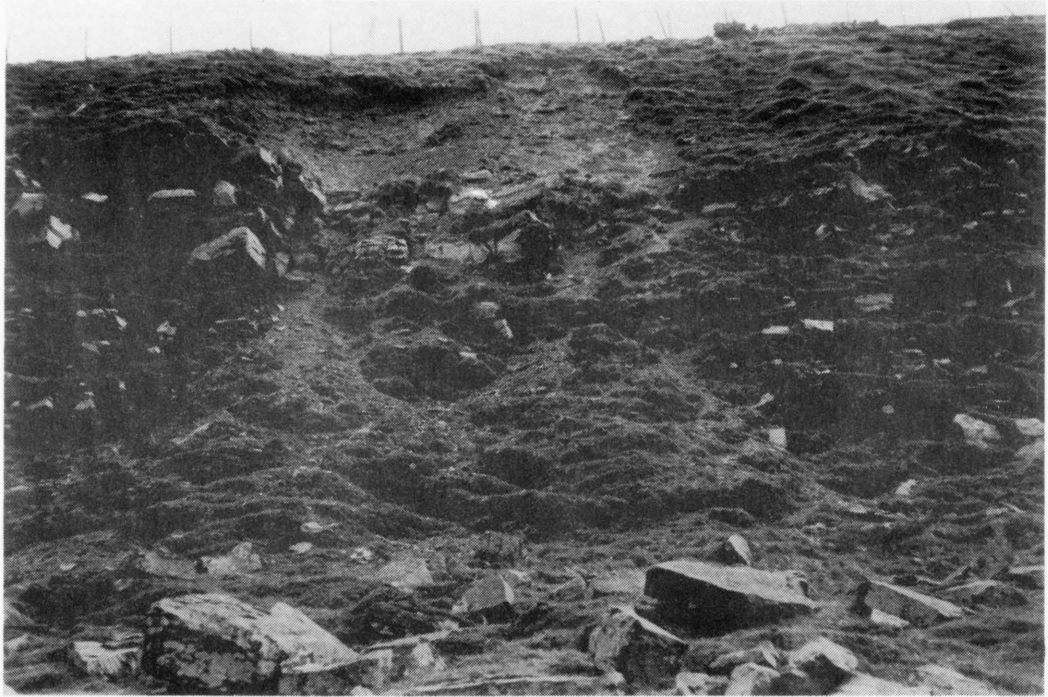
Plate 3. Two talus comes on the most westerly scar slope (at SK 19657838).

Fourthly, a debris slope occurs on the lower half of the scar faces, consisting of fallen material from the upper slopes. In parts, particularly the western landslide scar, merged talus cones are evident, composed of minor sandstone and shale fragments cemented by clays from slope wash processes (see Plate 3). The slope is thus characteristically concave in shape, but still very steep (29 degrees to 40 degrees).

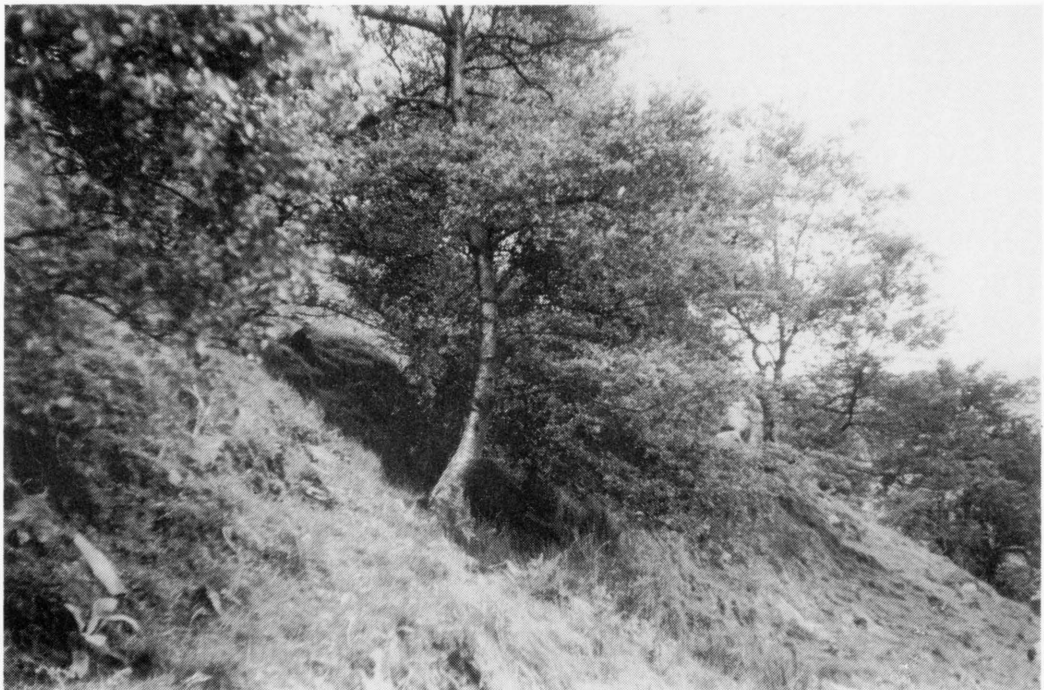
Plate 4. A tree with curved trunk on the most westerly landslide scar (at SK 19277820).

Secondly, the scar face occurs on the sandstone/shales mentioned in Table 1. It is characterized by two horizons of sandstone (Shale Grit) interbedded with shales/siltstones and thin siltstones of the undivided Millstone Grit (see Fig. 2 and Table 1 for a fuller description). The slope form is generally planar and very steep (29 degrees to 40 degrees) of 30–40 m high. Along all three scar faces, the continuity of the slope is often broken by a gently sloping terrace area. Present day instability includes minor regolith instability (curved tree trunks are especially indicative of unstable regolith—see Plate 4), small scale scree and areas of rockfall derived from the sandstone horizons.

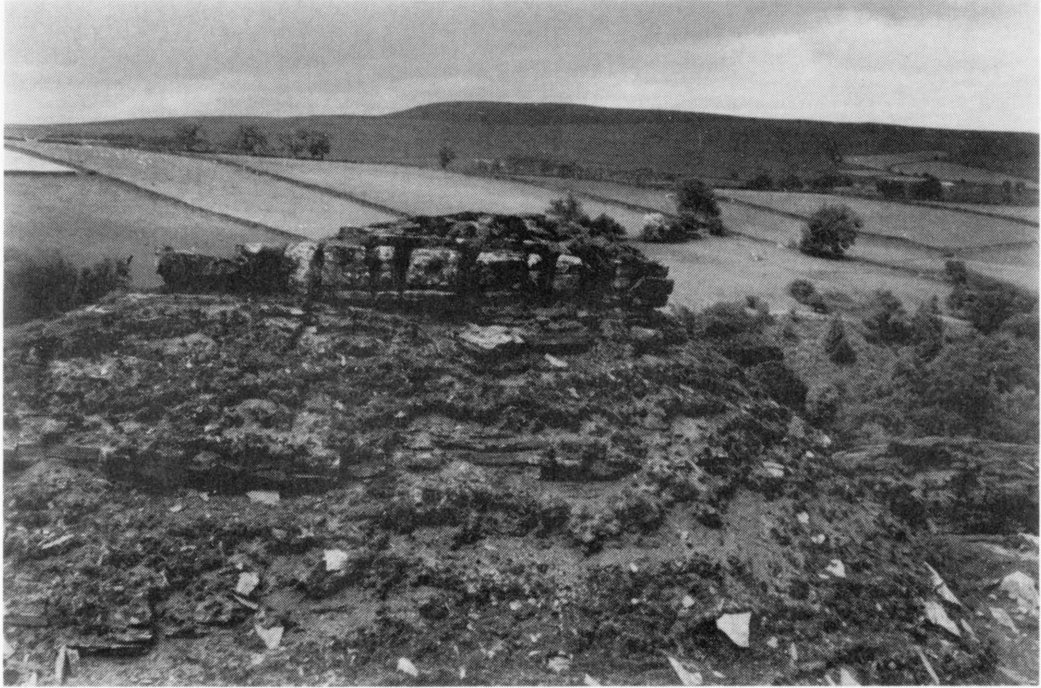
Plate 5. Stratigraphic succession of sandstone and shales is preserved in a slide block (at SK 19607834).

The slide blocks represent broken up segments of hillslope, and so still show a general stratigraphical succession of rock strata although mass movement has caused some disruption (see Plates 5 and 6). Those blocks with a well preserved succession would appear to have sandstone beds dipping into the valley corresponding to the regional dip and so very little rotation of beds, in these blocks, has occurred.

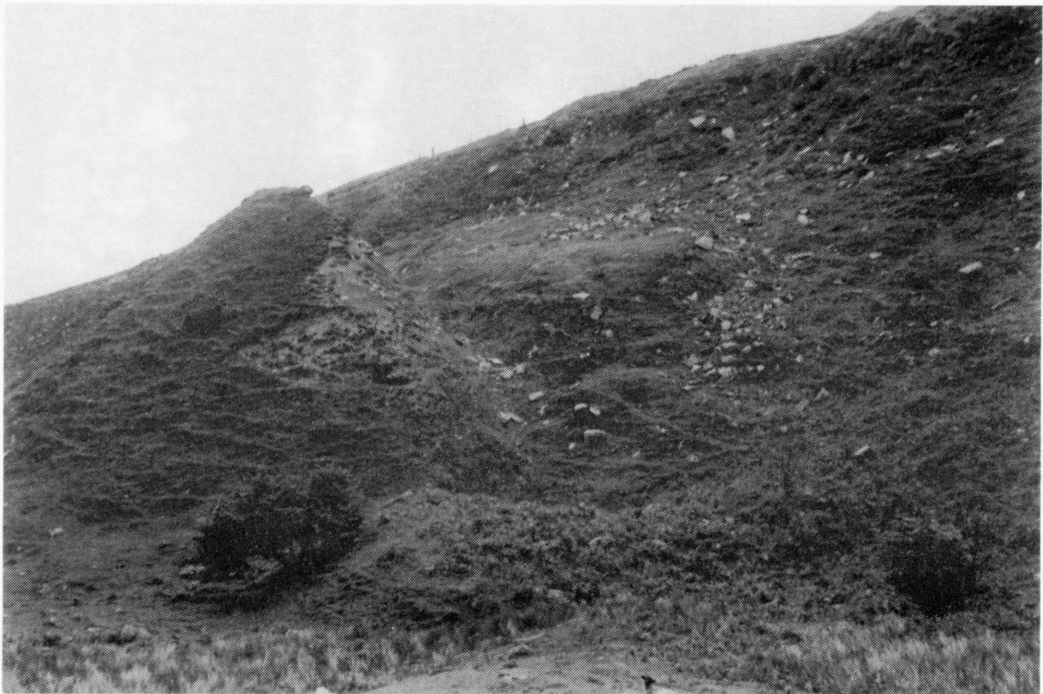
Plate 6. A large slide block near to the scar face of the most westerly landslip, its stratigraphic succession seen in Plate 5. On the scar itself, there is a smaller more recent rotational slump within the shales (at SK 19607834).
