# Developments in Nottingham's Sandstone Caves

A. C. Waltham and T. J. Cubby

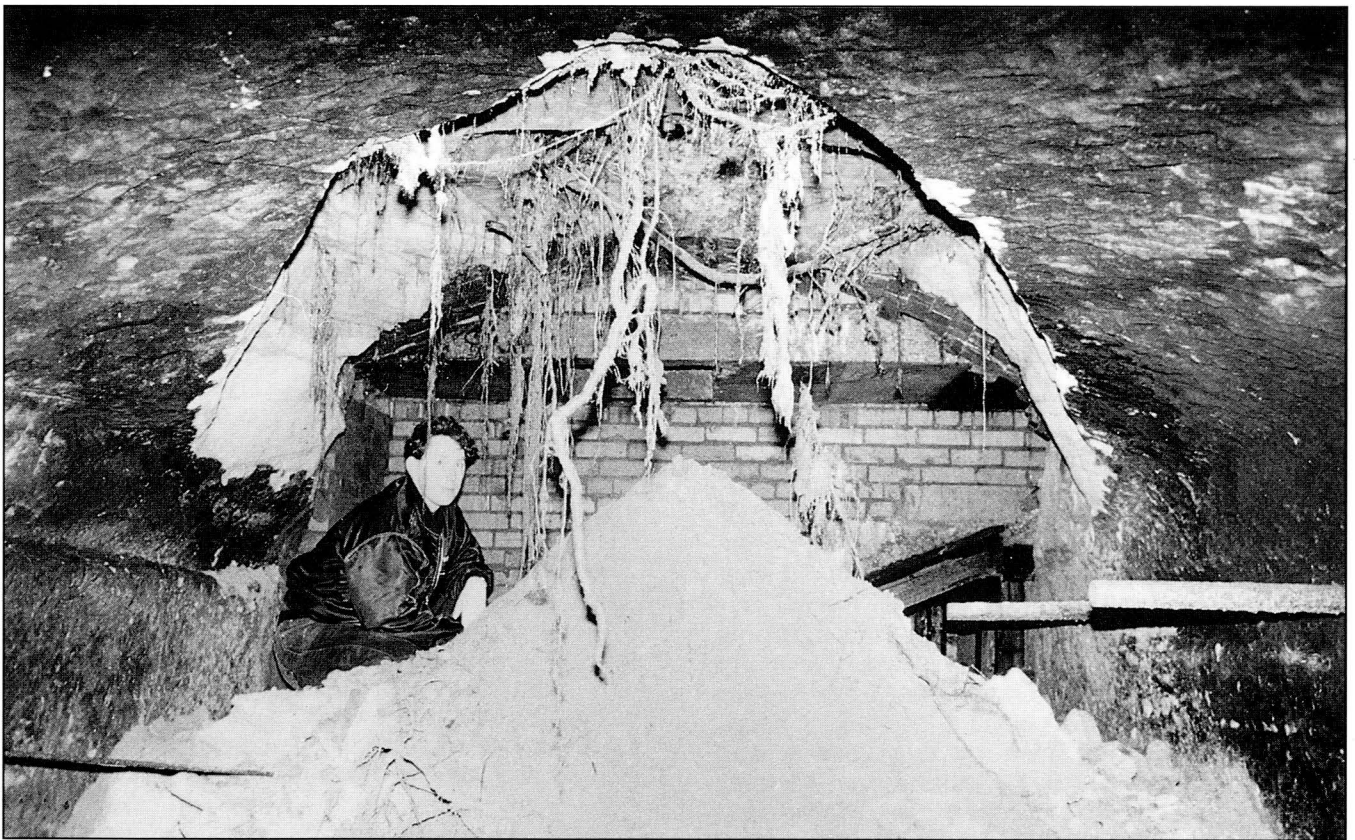
**Fig. 3.** Tree roots hang from the failure zone where a crown hole developed beside North Sherwood Street. The roof sandstone was little more than 1 metre thick, and tree roots had grown into it from a thin soil cover. The fallen debris on the floor is broken blocks of sandstone capped by a cone of completely weathered sand and soil. The brickwork in the background is not related to the failure (photos by Tony Waltham).

Water may be the dominant factor in cave roof collapses, but some failures in dry rock have had other causes. Tree roots are a significant factor in many roof failures in the caves. Roots cannot penetrate the unjointed sandstone, but they find their way into even the narrowest of fractures. Their growth then forces the joint faces apart and may cause lateral extension of the initial fracture; the rock deformation also opens up bedding plane weaknesses and creates new fractures in massive sandstone. Fine root ends hanging into a cave are fair warning of an incipient failure, and rather thicker roots are commonly exposed by a failure (Fig. 3).

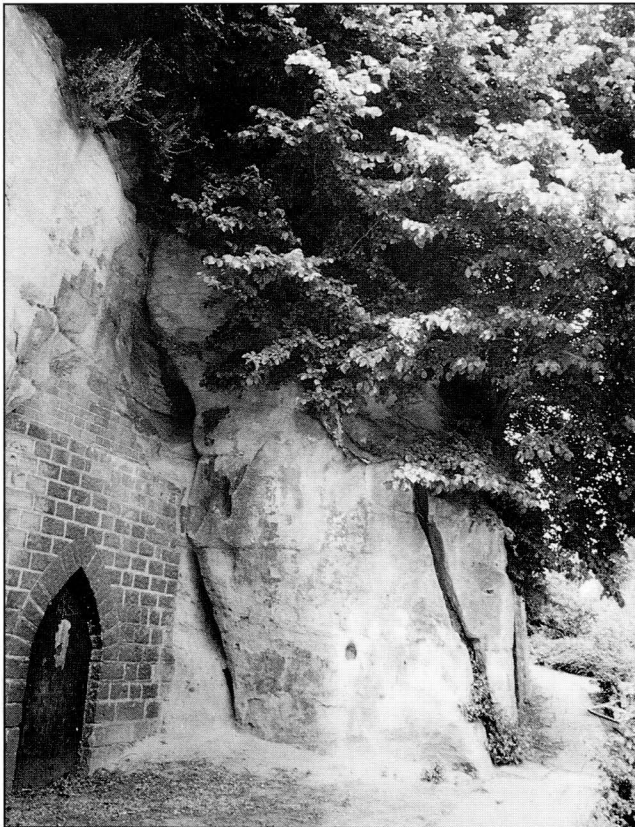
**Fig. 4.** The widening fissure beneath the unstable sandstone slab beside Castle Road, before the trees were removed and the rock was bolted.

The caves cut into the foot of the cliff along Castle Road have experienced a number of roof falls over the years, all near the cliff face where tree root growth has been active. The single most unstable piece of rock became detached above a steeply dipping joint that intersected the cliff face at its toe (Fig. 4). This joint was being heaved wider at a rate of 1mm per day in the summer growing season, and

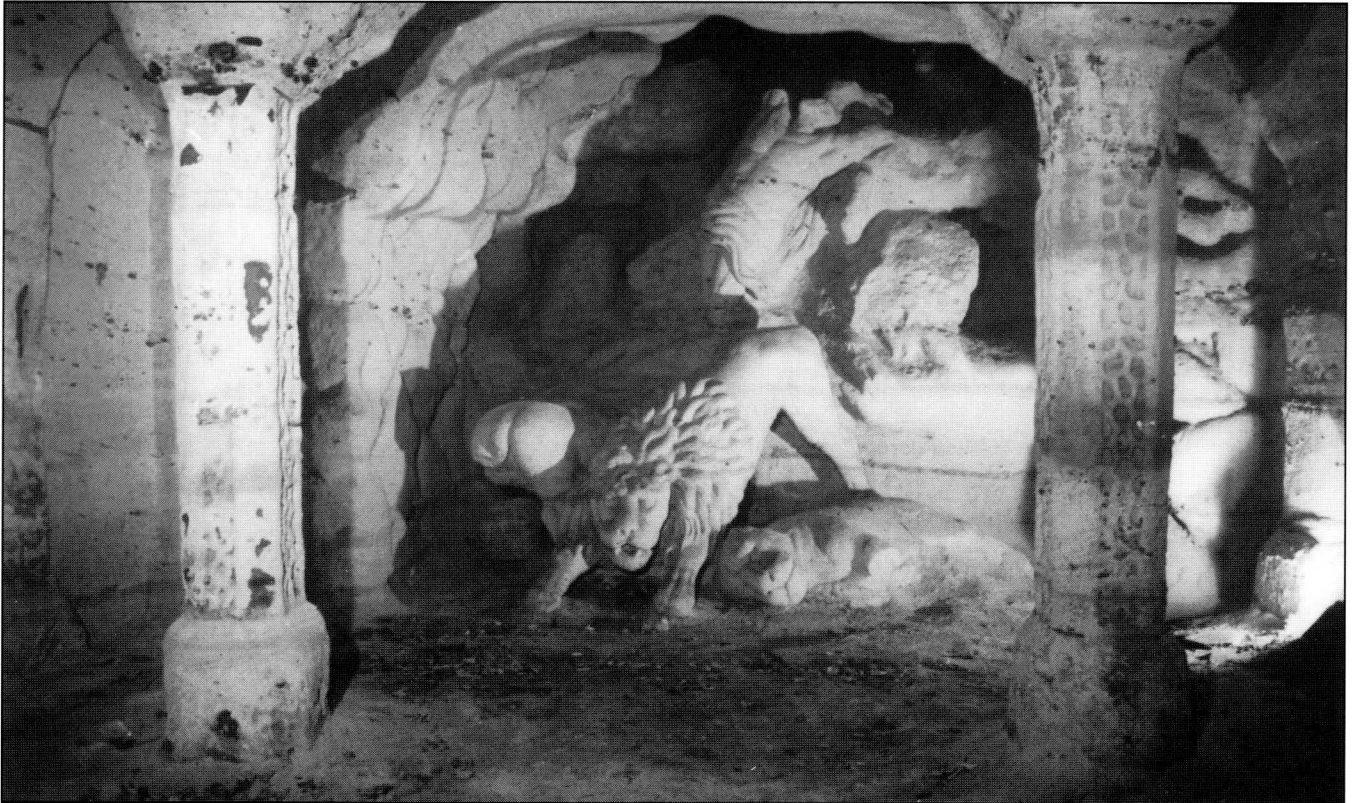
**Fig. 9.** The statues of Daniel in the Lion's Den, in their cave within The Park. All surfaces are losing sand grains due to weathering, and unswept loose sand is visible at the foot of the two columns. The view is from the open cave entrance.

This scale of weathering rapidly destroys any detail or features carved into the sandstone. The caves that have suffered most are those excavated at the behest of Thomas Herbert, and which contain the splendid statues carved into the underground bedrock (Nix, 1984a; Waltham, 1996b); they now lie within The Park. Daniel in the Lion's Den is the finest of the statues (Fig. 9), and it is steadily shedding sand grains, thereby losing much of its finer detail. Rates of wall decay have been measured by catching the fallen sand grains at the foot of the cave walls, and up to 20 grams of sand per week have been collected in trays just 700mm wide (Cubby, 1997). This translates into a mean rate of wall retreat of over 0.3mm per year. The wall disintegration varies in different parts of the caves (Table 1), and the mean retreat rate at the statues is about 0.1mm per year. Under uniform conditions during the 160 years since they were carved, in about 1837, the bare rock surfaces of the statues would have retreated by about 16mm.

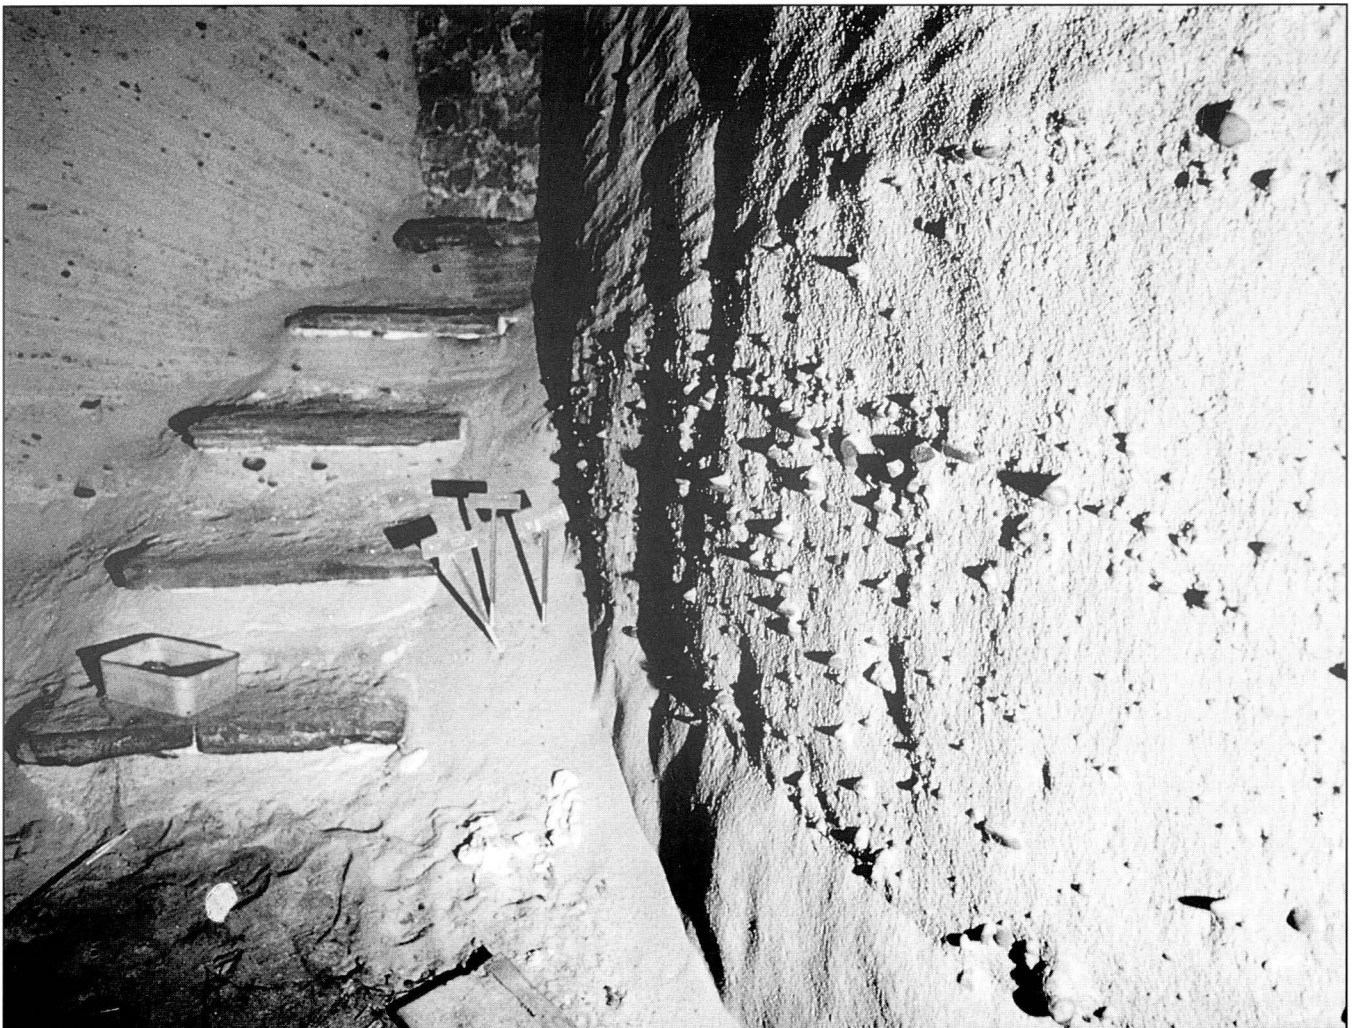
**Fig. 10.** The heavily weathered wall of the Herbarium Cave, which has its unprotected entrance in The Park close to Daniel's Cave. Pebbles protrude from the rock due to the loss of weathered sand grains, some of which are still banked along the foot of the wall.

Caves carved into the more conglomeratic facies are distinguished by resistant quartzite pebbles which protrude from the walls where the matrix sandstone has weathered back (Fig. 10). Mean pebble protrusion in the area around the Daniel statues is 22mm, and the unweathered zone at the rear of Daniel's Cave has pebble protrusion of about 7mm. The latter figure may represent the cave wall profile as it was originally cut, in which case subsequent weathering has removed about 15mm from rock surfaces in the statues area; this value for wall retreat matches closely that calculated from current rates of wall degradation.
