# Geology and engineering aspects of the Leadenham By-pass, Lincolnshire

**Abstract:** This article gives an account of a non-geologist's encounter with the geology of the Lincoln Edge, as experienced during construction of a by-pass road for the village of Leadenham, Lincolnshire in 1994-95. The geology and related constraints determined during the ground investigation are described, together with their bearing on the design and construction of the road scheme.

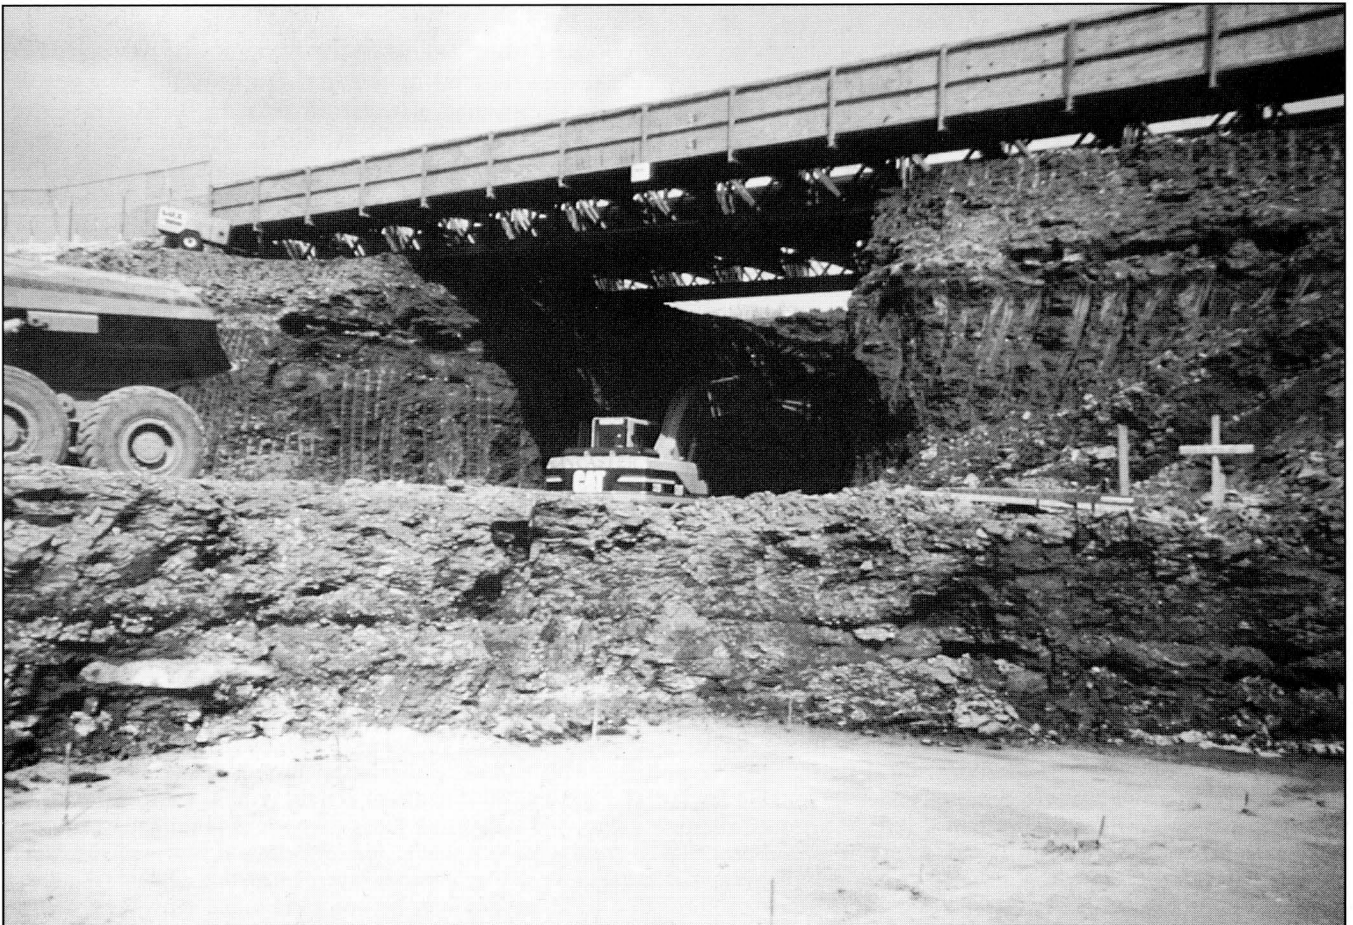
**Fig. 2.** Temporary overbridge of A607 road, supported on the Marlstone Rock Formation (upper strata) overlying Brant Mudstone Formation. The concreted foundation for the permanent bridge is in the foreground.

In May and early June the A607 road was diverted away from the site of the new bridge. Use was made of the loadspreading capabilities of the Marlstone Rock Formation to provide foundations for the temporary 'Bailey' bridge (Fig. 2) that would carry the road over the cutting to be excavated beneath. The contractors initiative in providing this temporary bridge was a key element in shortening the contract period by several months. It enabled the A607 road traffic to be freed from conflict with construction vehicles, which could now pass from one side of the A607 road to the other by going underneath it.

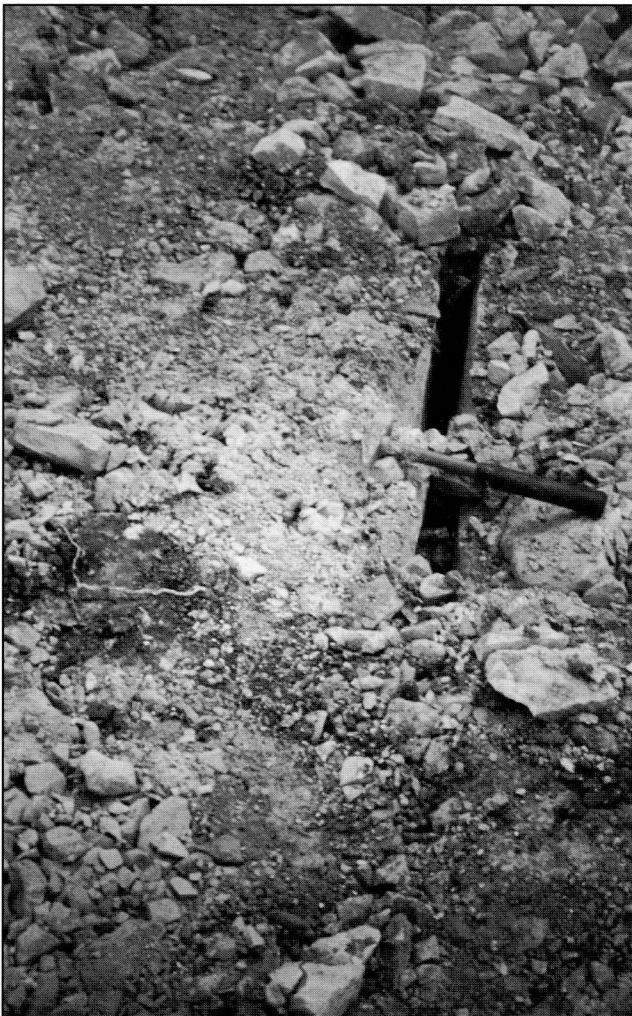
**Fig. 7.** Joints up to 100mm wide in Lincolnshire Limestone. These trend parallel to the valley side at the top of upper escarpment, and have opened up as a result of cambering of the Limestone.

On excavation, the Lincolnshire Limestone at the top of the Fulbeck Hilltop cutting proved, as expected, to be heavily fissured with joints up to 100mm wide (Fig. 7). In the more weathered upper beds, these joints were filled with a gravelly sandy clay derived from both the weathered limestone and the overlying soil. The joints were open in the less weathered, moderately strong limestone beds at

depth. The open joints were found to parallel the NW-SE direction of the strike of the bedding planes and the alignment of the scarp edge at this location. Here, on the very edge of the escarpment, the beds were found to dip at up to 10 degrees towards the south or south-west, whereas on the dip slope the dip was measured as 1-2 degrees to the east. This is a textbook example of cambering, induced by spring sapping of the Grantham Formation sands and clays by groundwater issuing from the base of the Northampton Sand Formation. It was concluded that the existence of the open joints was unlikely to have any effect on the stability of the cutting since they were at an oblique angle to it. However, their width demanded that they should be grouted up with weak concrete and capped over prior to road pavement construction, to avoid the possibility of localised depressions. Though this entailed a slight additional cost to the scheme, the fissuring (after soakage tests) permitted the number of large diameter 6 metre deep soakaways, designed to be constructed at the eastern end of the scheme (see above), to be substantially reduced.
