FLOOD REPORT

Summer rainstorms bring more geology lessons for planners

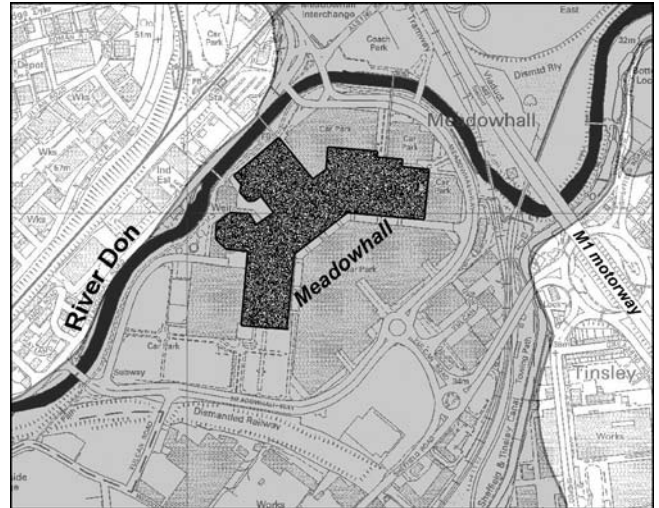
The Meadowhall Centre, outside Sheffield, sited on the flood-prone alluvium (shaded) of the River Don floodplain (from DigMap, the BGS digital geological map of Great Britain, with topography by Ordnance Survey).

Geological maps show the distribution of deposits such as alluvium, indicating the extent of the floodplains along which excess water is conveyed during extreme rainfall events (see *Mercian Geologist*, 2001, p126). This relationship was highlighted by the flooding that occurred at the Meadowhall Centre, on the River Don floodplain in Sheffield, first on the weekend of June 15-18 and then, with far more devastation, on June 24-25. During the culmination of

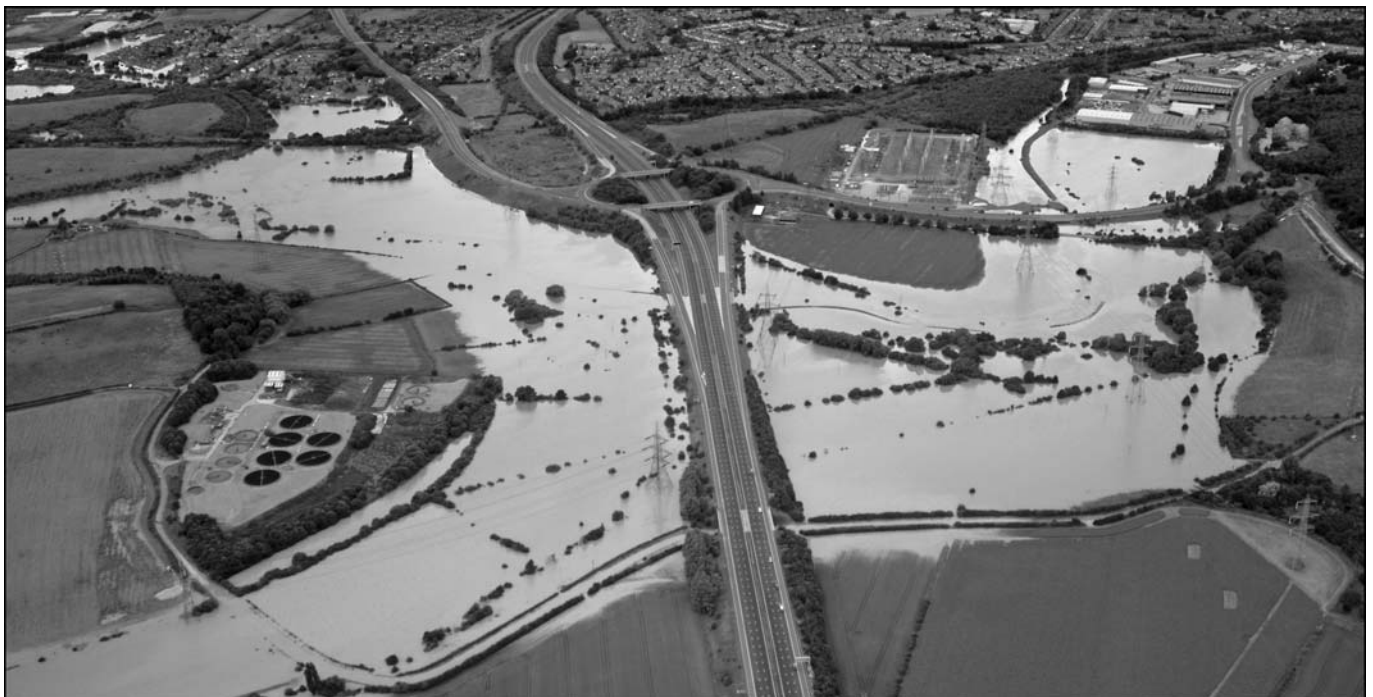
Active floodplain of the River Rother, with backflooding into Catcliffe village (top left), beneath junction 33 on the M1.

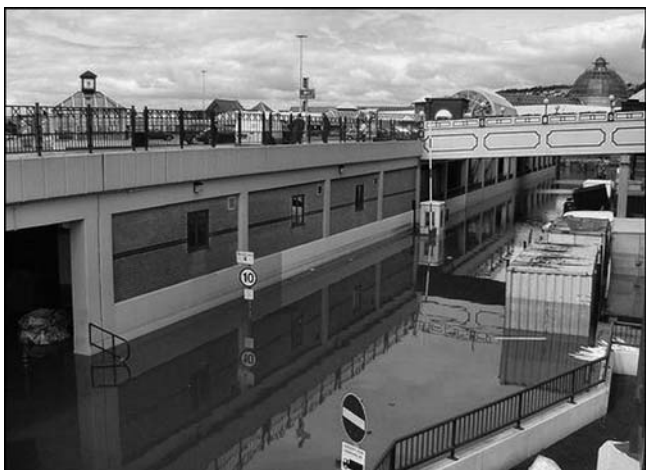
Floodwater in the Meadowhall Centre.

this flooding, many industries and houses were also inundated, people were stranded overnight and some even had to be rescued by helicopter. Although there is some degree of flood protection along the River Don, either in the form of defences or ground raised by building construction, this has been at the cost of confining and concentrating streamflow. When the Don eventually overtopped its banks, it did so with predictable consequences for those areas that were slightly lower than the artificially elevated 'safer' parts of the modified floodplain. Meadowhall did not re-open until July 2nd, and then only 120 of the 273 stores were back in business.

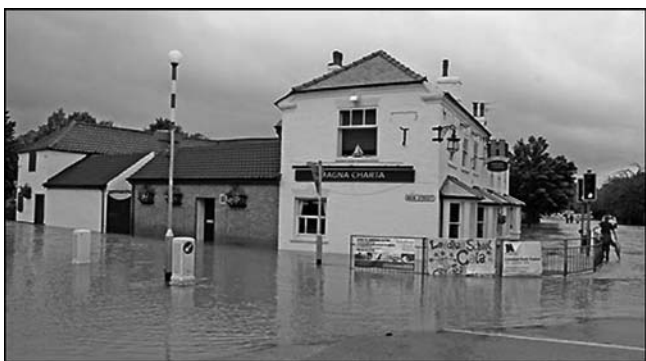
The Magna Charta public house in Lowdham, flooded on June 25th (photo: James Brunton).

In Lowdham, the specially designed flood-prevention basin (which doubles as a cricket pitch) overflowed, and the Cocker Beck was in many places constricted by badly designed bridges or culverts. These form ‘pinch-points’ that obstruct flood flows (ie, they encroach on the floodway), and so cause backing up of the flood waters - which then spilled over along roads and into houses built on or close to the floodplain. Houses in Woodborough were again flooded where the culvert that lies partly beneath the main street could not carry the storm flow; this was at least in part due to silting in the tunnel section, but is probably now exacerbated by a small reduction in its gradient induced by mining subsidence in 1990.

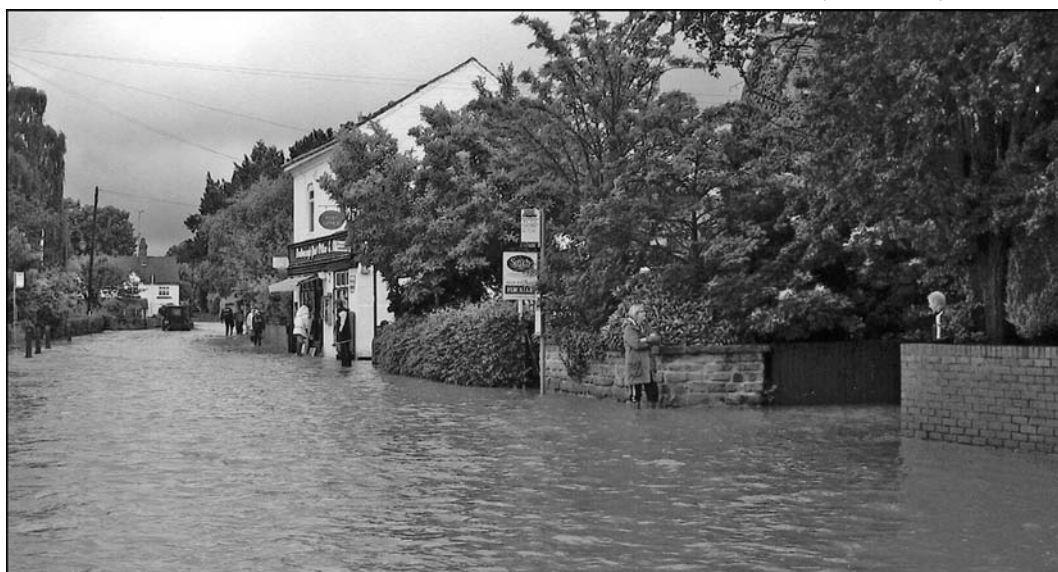
The main street in Woodborough, which was flooded four times by the series of heavy rainstorms this summer (photo: John Hoyland, www.woodborough-heritage.org.uk).

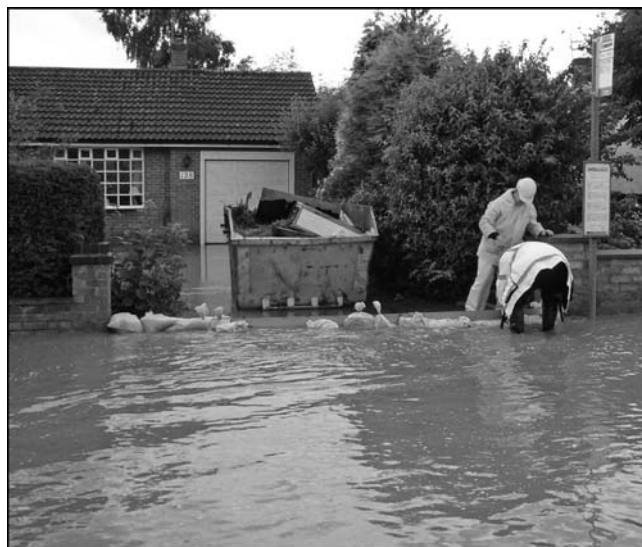
Sandbags against rising water to protect a bungalow on the main road through Woodborough (photo: Pam Footitt).
