Two Notable Earthquakes in 2008

Abstract: Reports on this year's very modest earthquake in Market Rasen, Lincolnshire, and the much larger event in Sichuan, China.

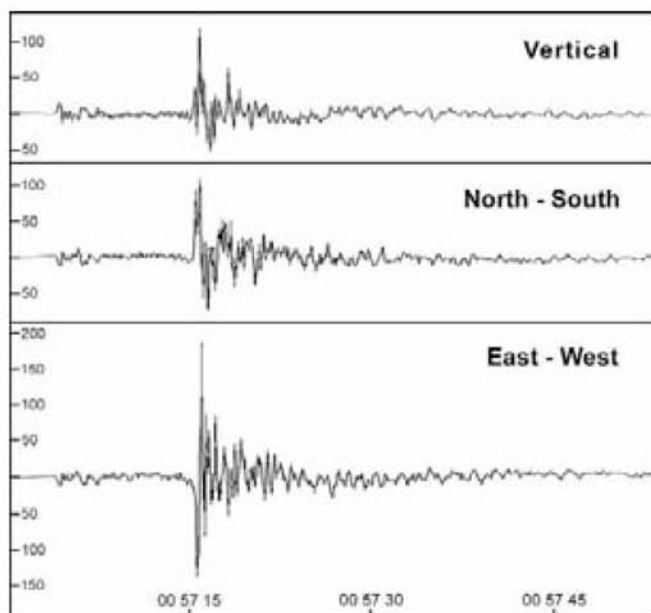
Figure 1. The February 2008 event recorded on the Charnwood Lodge siesmogram. The record shows ground displacement on the three directional components, with scales in microns, and times in hours, minutes and seconds (courtesy of BGS Seismology and Geomagnetism section).

On the 27th February 2008, at 00:56 GMT, an earthquake occurred in Lincolnshire, the trace of which was recorded on BGS seismograms (Fig. 1). It was felt throughout the East Midlands and across England and Wales, with the most distant reports coming from Aberdeen, Truro and Ireland (Fig. 2). Most people would have been asleep at that time and the reason for our apparent alertness may be that the 'felt' part of the event lasted for several seconds, beginning with an audible rumble that would have woken many up. The earthquake was widely reported in the British media, and several TV crews filmed on the same day at places such as Gainsborough, where damage occurred, and also at the British Geological Survey at Keyworth.

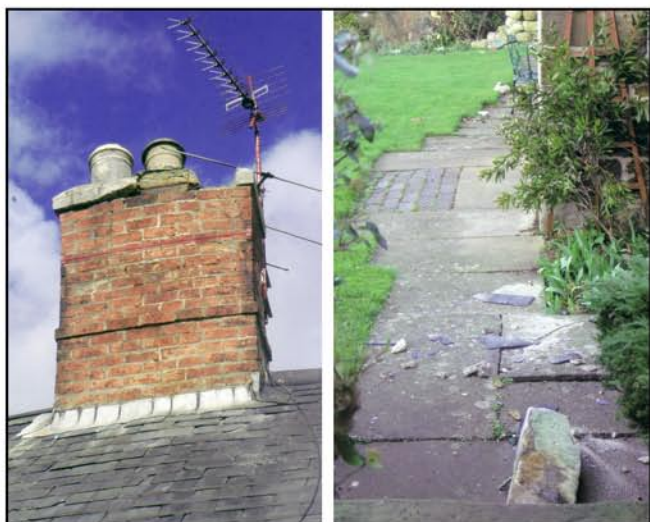
Figure 3. Earthquake damage to John Aram's house, where limestone coping fell from the chimney into the front garden.

In the morning we noticed that several pictures were hanging at strange angles, a stack of CDs had fallen over and a framed photograph had fallen over and broken. Going outside I was greeted by a large slab of limestone capping that had fallen from the chimney stack on the main part of the cottage, and now lay on a broken slab of York Stone near the door; bits of broken slate, brick and cement were spread around and onto the lawn (Fig. 3). Just below the brick stack (which was intact, as were the two chimney pots), there was a hole in the slate roof and a broken lath was visible, where the capping stone must have fallen on a corner before rolling or sliding down the roof to hit the ridge of the porch over the front door. Here it broke further, sending a smaller part of the stone to one side, damaging slates on both sides of the ridge tiles before reaching the ground.

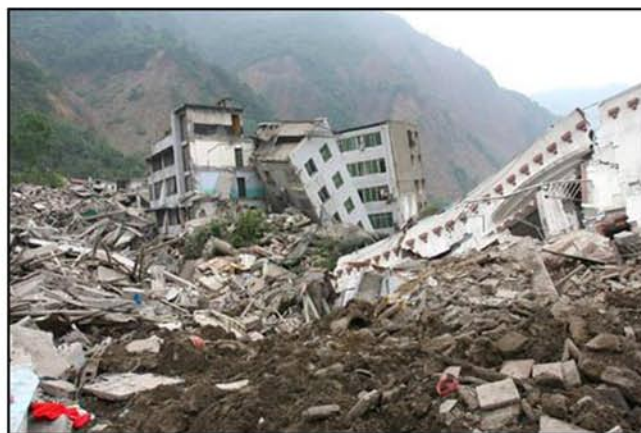
Figure 4. Total failure of concrete buildings after the earthquake hit the town of Beichuan (photo: Xinhua).

Two months after the modest Market Rasen event, a major earthquake struck in the Sichuan province of China. At 7.9 on the Richter scale, it caused massive damage (Fig. 4) when it struck at 2.28 pm local time on 12 May 2008, along the western margin of the densely populated Sichuan Basin (also known as the Red Basin). At least 70,000 people died in the earthquake, and another 18,000 were still counted as missing three weeks after the event.

Nearly all China's cities and towns (including most of those in the Sichuan Basin) are sited on flat ground - where they are bicycle-friendly. But this also places them on soft alluvial sediments that amplify earthquake waves instead of dampening them; this is the well-known jelly effect (seen when carrying a jelly from kitchen to dining room after turning it out onto a plate as centrepiece for a children's party). Structural damage was exacerbated due to China's recent frenzy of construction, when concrete buildings have not achieved appropriate standards (whether this was due to corruption and bad design or to hasty and inadequate quality control is open to dispute). Especially on soft alluvium, these buildings were among the first to fail (Fig. 6), and when the earthquake unfortunately occurred in mid-afternoon over 11,000 children and teachers died in their collapsing schools. In total, more than five million buildings collapsed in this one earthquake.

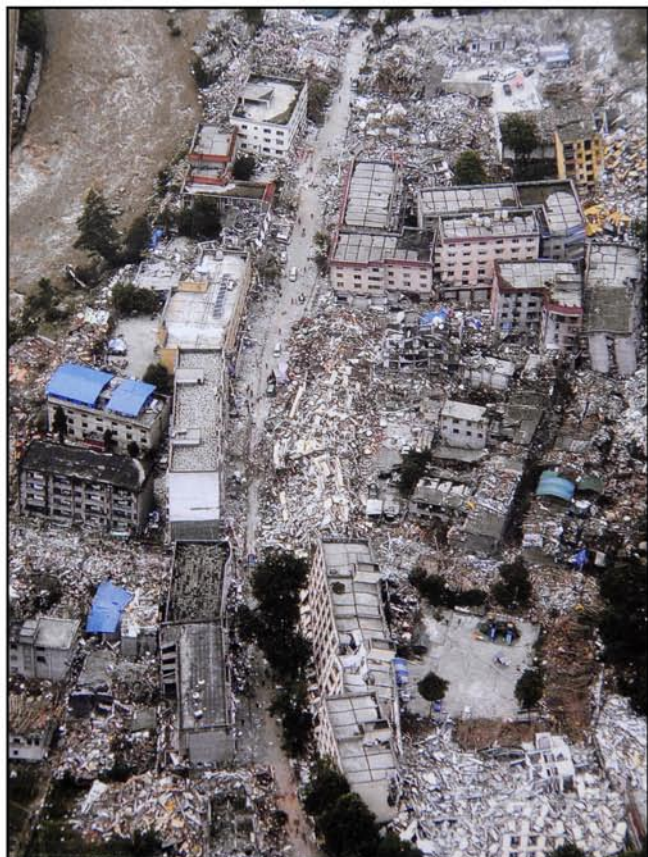
Figure 6. Almost total destruction in the town of Yingxiu, close to the earthquake epicentre (photo: Xinhua).
