REPORT

Nottingham's Castle Rock

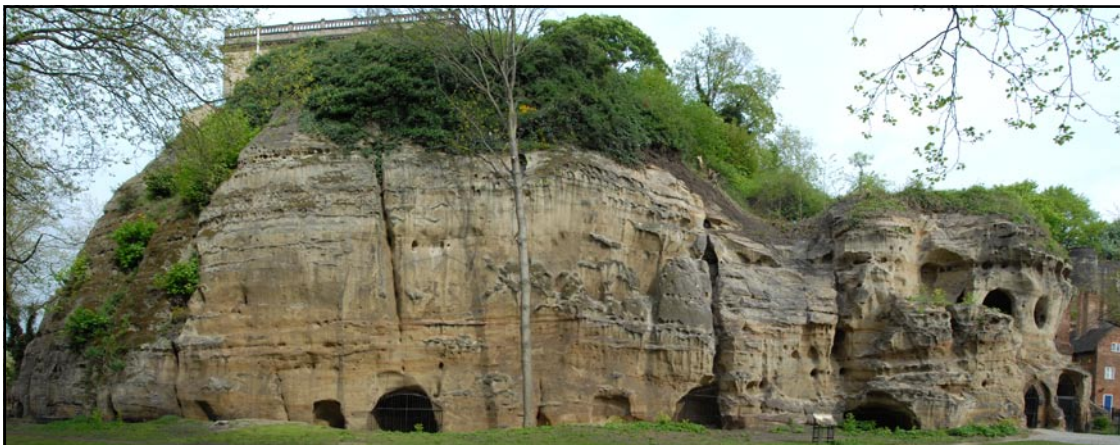
The newly cleaned south end of Castle Rock, as seen from Castle Boulevard.

So the current stabilisation works started with a major clearance of the vegetation. Some of the larger trees have been taken down because their roots were

reaching far into the rock; shrubs that had established in open joints and fissures are being removed; and the great screens of hanging ivy have been cut away. At the foot of the Rock at the corner into Peveril Drive, the holly trees have been removed as their roots were breaking down the roof of the nearby Water Cave. Two large trees on the Castle Boulevard lawns have also been removed, but a single tall ash tree has been retained at the wish of the planners because it is a native species, though it now looks rather out of place. A side effect of all this has been a huge improvement in the appearance of Castle Rock. Especially round its southern end, west of Brewhouse Yard, it is once again a bold geological feature, instead of just another blob of urban greenery. The Nottingham Castle Sandstone has regained its type locality back from the holly and the ivy.

A cover of soil and low plants is kept on the upper slopes that lie back at lower angles, and one of the main challenges for the contractors has been to manage and control this boundary between soil cover and bare rock along the crests of the main faces. Once cleared of vegetation, the works follow on with repairs to the rock. Judicious concreting and reinforced plastic coating is under way where needed, notably sealing the main fissures where roots deep inside cannot be removed but must be prevented from re-growth. Rock repairs are almost invisible where loose sand is rubbed by hand over the cement or plastic before it has gone hard, to create a good "sandstone" surface. A careful search reveals where this has been done, but most casual observers just do not see most of this critical repair work. This will include repairs within the caves, including the Western Passages which it is hoped can soon be re-opened to extend the tours through Mortimer's Hole, creating the loop tour that was so popular some years ago.
