Building stones of St Mary's Church at Colston Bassett, Nottinghamshire

Albert Horton

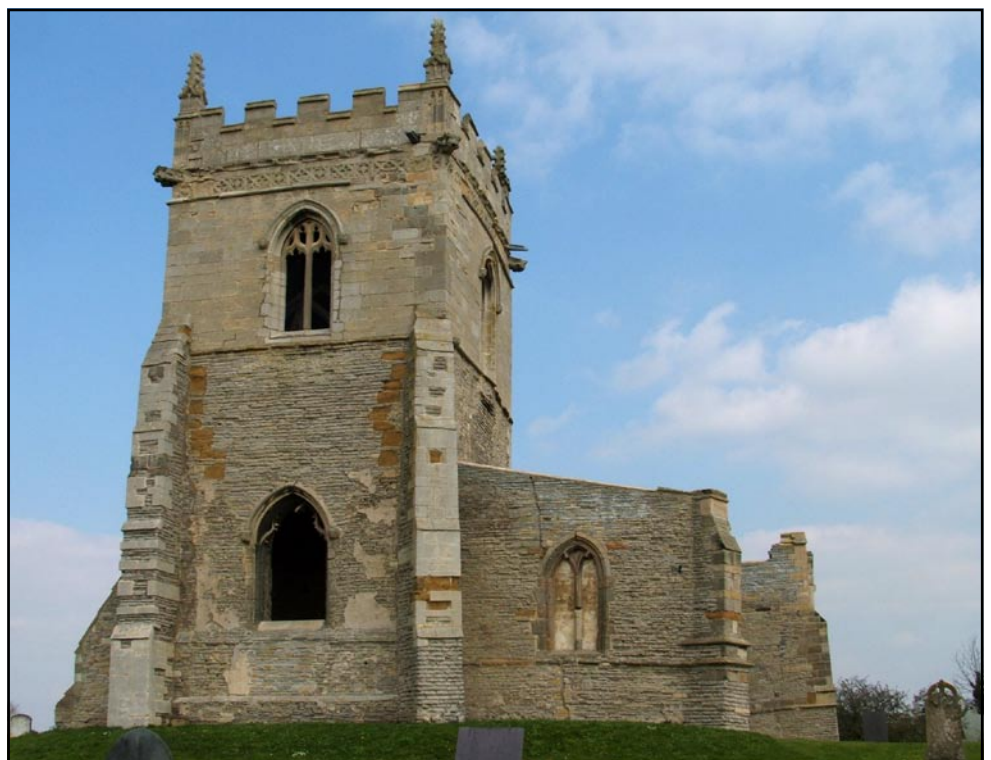
Figure 1. The surviving remnants of the walls and stonework at St Mary's Church, seen from the west, on its low hill northwest of the village of Colston Bassett.

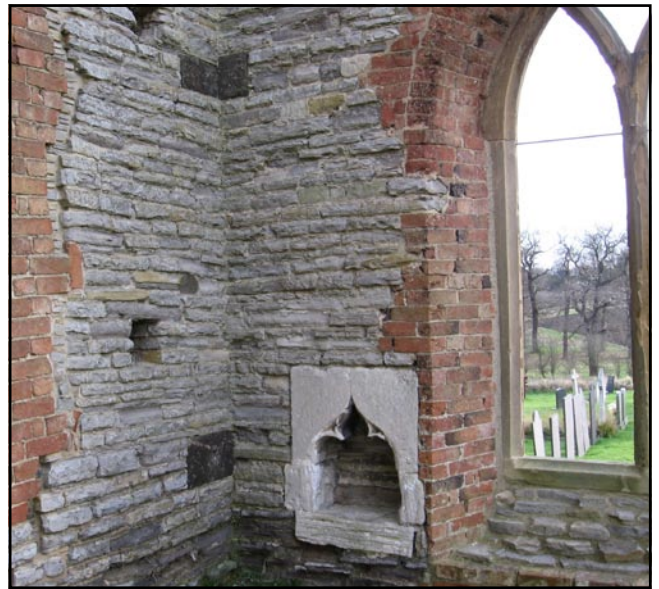
Figure 3. Southeast corner of the Chancel with Blue Lias rubblestone enclosing a piscina carved from a block of oolite adjacent to a C19th window.

the internal wall. To the east, the wall contains three courses, the lower mostly of oolitic, with Sandrock dominant above; it was rebuilt in the 19th century. It includes a second contemporary Y tracery window. The westerly window has been partly destroyed; its opening is defined by shaped blocks of purplish Northampton Sand, shelly calcareous ferruginous bioturbated sandstone. Internally, only the left side and part of the arch of the blocked off window survive; the blocks are five of Northampton Sand, two of Sandrock, two of oolite and one of grey sandstone. An early 19th century brick wall extends from this window frame to the recently infilled, 10 cm gap in the east wall (Fig. 3). And from there, the internal wall is built of Blue Lias.

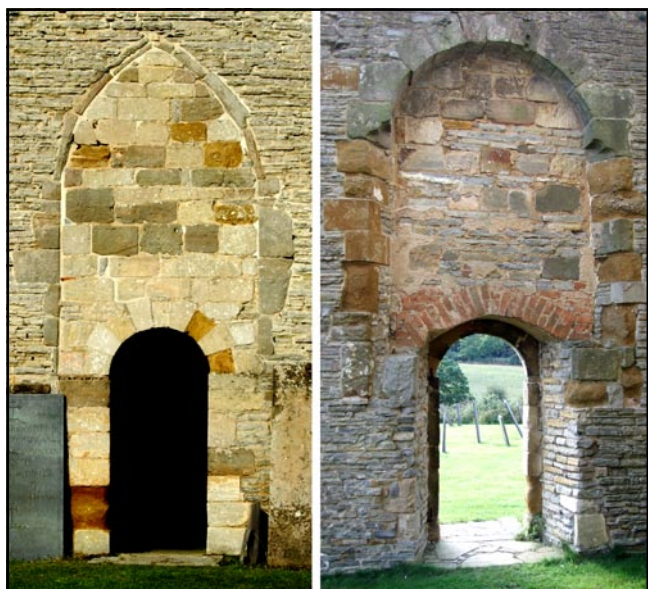
Figure 4. Southwest door of the South Aisle, with its contrasting exterior and interior designs.

A similar tall opening occurs opposite the tower on the internal south wall (Fig. 4). It has a grey sandstone arch above a Sandrock frame, including two oolite and one sandstone replacement blocks. Externally it has a pointed arch which almost reaches to the top of the wall. The frame is grey Triassic sandstone. Possibly originally a window, it was replaced by a small door of Classical style, the infill comprising salvaged blocks of oolite, Triassic sandstone and Sandrock.

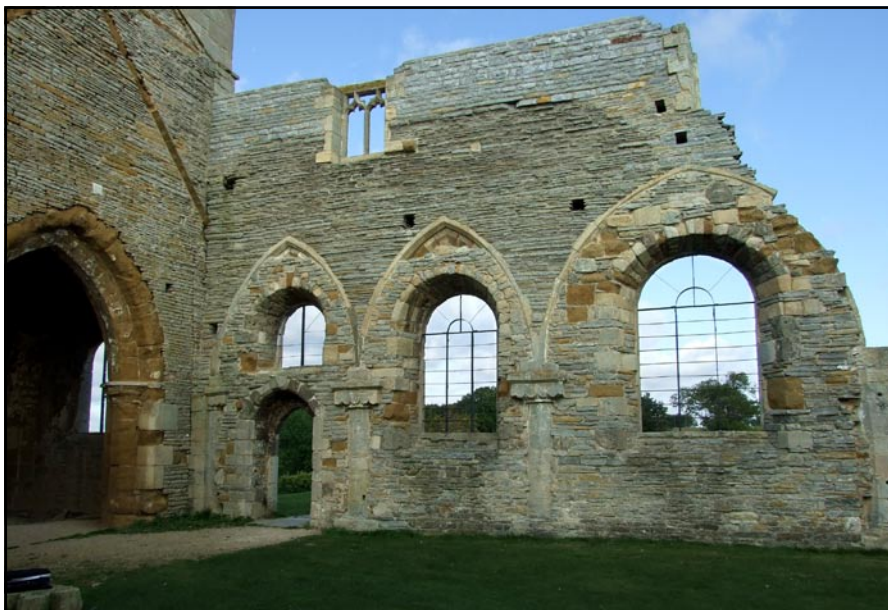
Figure 7. North Arcade Nave Wall. The two and a half rounded columns with scalloped capitals, all Lincolnshire Limestone, are typically Norman. Subsequently the North Isle was raised with the insertion of ribbed pointed arches mostly oolite with some sandstone. The first two are set below the ironstone roof rib of the tower, but the third is taller and wider. Georgian style windows were inserted when the arcade became the Nave Wall.

Internally, the north wall reveals three round columns that rest on square bases and support square capitals with deeply carved flutes (Figs. 7 and 8). These are typical

of Norman style (c1130), and are made of Lincolnshire Limestone oolite. The fourth, most easterly, column is octagonal (C 13th-14th), also of oolite, as are the pointed and chamfered arches above. The east face of the tower shows evidence of two roof structures (Fig. 9). The lower, Sandrock roof rib is steeply inclined suggesting an older reed or thatched roof; it intersects the Nave wall just above the points of the first and second arches but below the taller third arch. One can conjecture that the round pillars once carried typical semicircular Norman arches, which were subsequently replaced by the present arches. The higher oolite roof rib is less steeply inclined, with shoulders, and is clearly related to construction of the Clerestory.

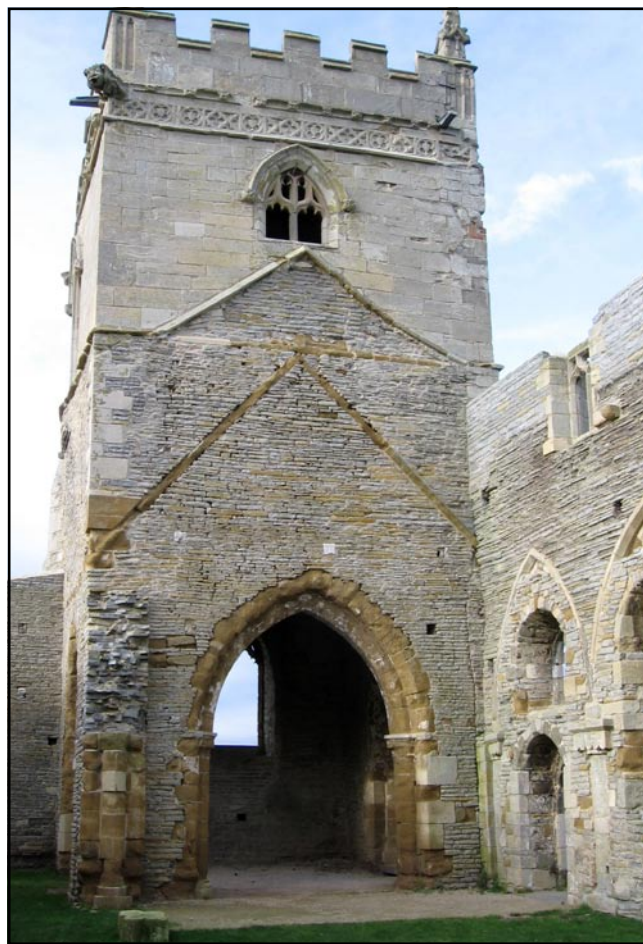
Figure 9. East Face of Tower with five faceted arch built of Sandrock (Early English style, C 13). The two ribs relate to original roof lines. The lower Sandrock rib ends just above the North Aisle Arches. The higher hipped rib consists of Lincolnshire Limestone and marks the building of the Clerestory and reconstruction of the Tower in the Perpendicular style (C 14).

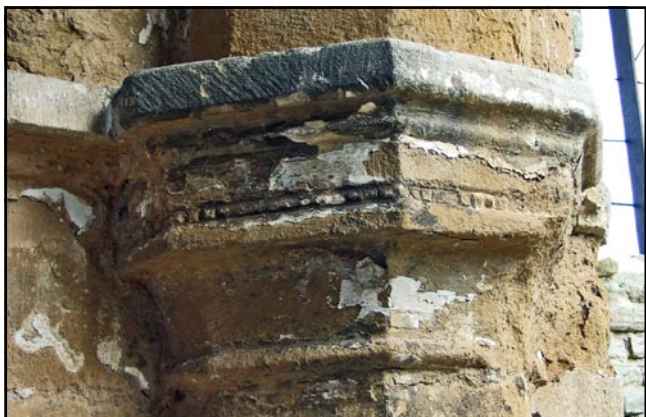
Figure 10. Nailhead decoration on the capitals of a column supporting the Tower's arches, with traces of old whitewash.

The lower part of the tower's inner walls are built of Blue Lias. Originally there were three arches and associated responds (half column supports), all chamfered (five-sided) and built of Sandrock. The capital above the northeast respond has a band of nailhead (small pyramid) decoration (Fig. 10) that is typical of Early English style (mid C 13th). The others are similar in shape, but

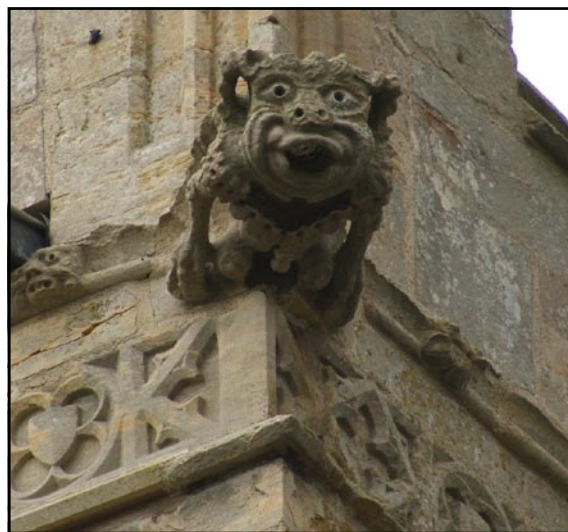
Figure 13. Gargoyle at SW corner of Tower, set above a carved frieze, both in Lincolnshire Limestone.

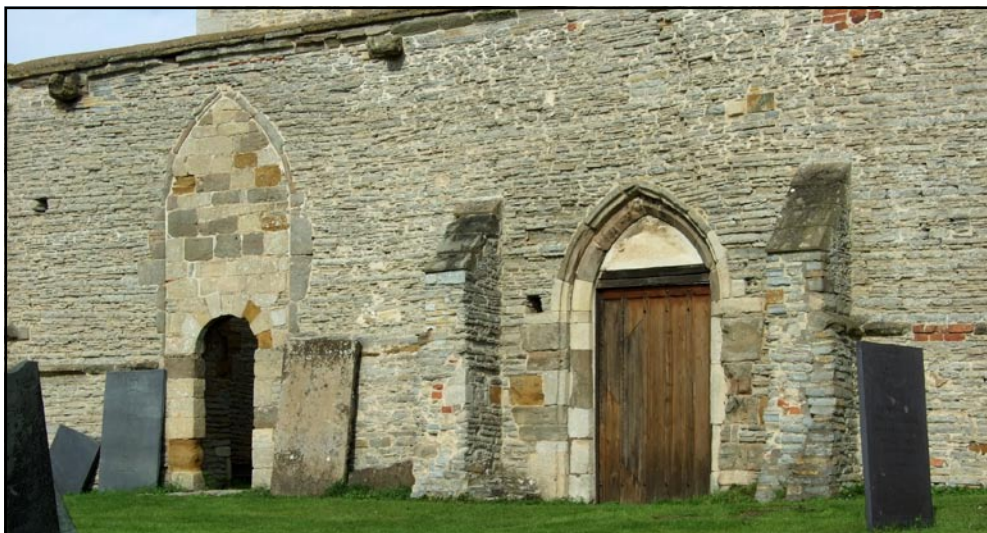
Figure 14. Part of the South Aisle with original porch door.

The original South Door to the east was enclosed by a porch, the remnants of which have been used as buttresses (Fig. 14). Externally it has a pointed arch with a hoodmould and chamfered frame, composed mostly of Triassic sandstone at the top and oolite below. On the right side, there is a block of coarse shell-debris-pellet spar-cemented limestone. Internally the door has an almost rounded arch (now fractured) composed of grey Triassic sandstone blocks with oolite and Sandrock below. This encloses a smaller pointed arch set above a wooden beam with a door below.

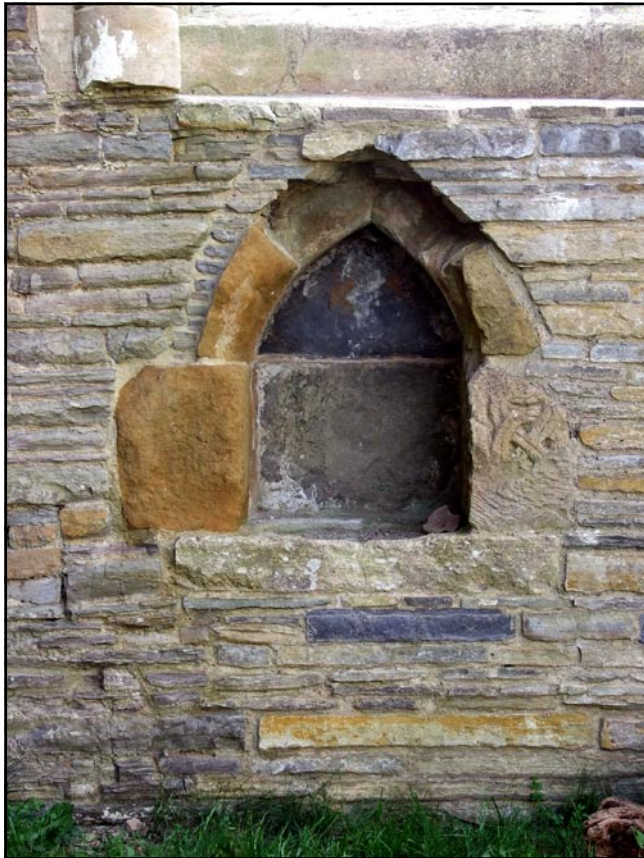
Figure 15.
*Reconstructed
piscina with
Saxon carving.*

The internal walls are of Blue Lias. The southern end of the west wall contains the trace of a window infilled with Blue Lias rubblestone. The window has a pointed arch consisting of two thin slabs of Triassic sandstone. Only the right upright remains and comprises Northampton Sand, Sandrock and oolite blocks above a Sandrock sill. This must have been sealed off prior to the insertion of the adjacent south window (Perpendicular style, c1370-1530). The small piscina beneath the infilled window has been reconstructed to include an oolite block with Saxon carved-knot tracery, which was discovered in a wall during the conservation (Figure 15). This is the oldest stone in the church. In contrast the back of the

piscina comprises a slab of grey sandstone beneath a piece of Swithland Slate, possibly a fragment of an abandoned gravestone.

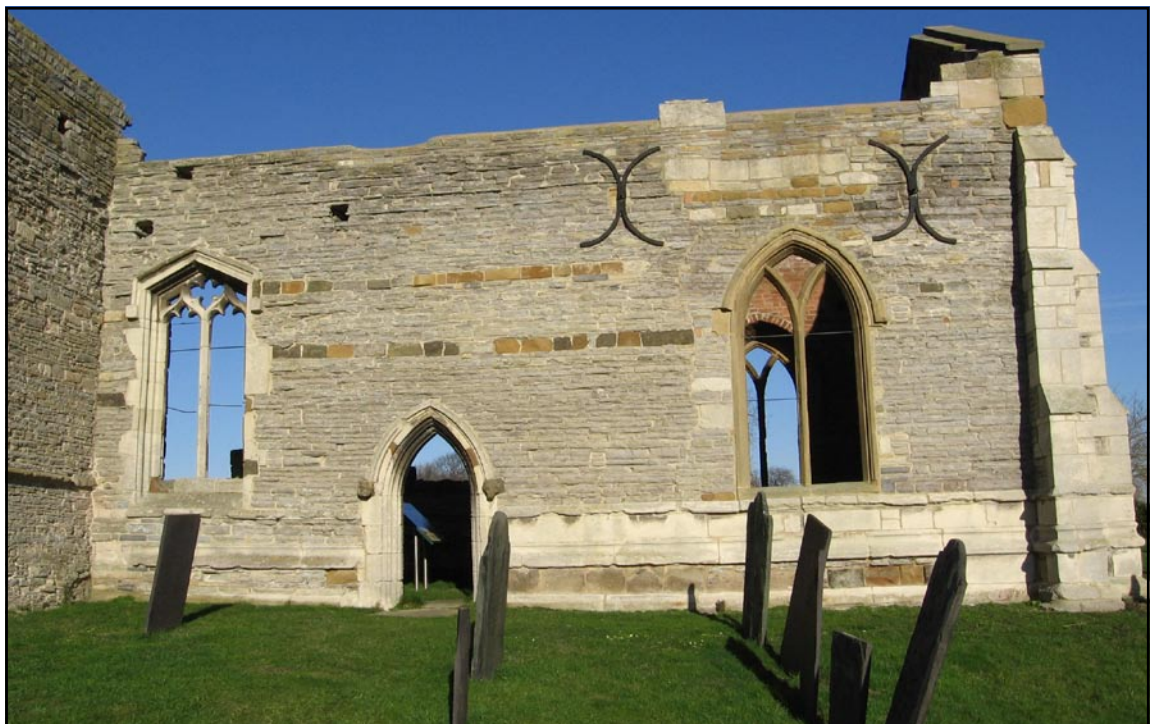
Figure 16. *The
south wall of
Chancel with its
repeated repairs.*

This was the most unstable part of the church, so two steel tie bars restrain the north and south walls. Externally the south wall is mostly Blue Lias but contains two string courses with diverse blocks (Fig. 16). The lower string is Northampton Sand sandstone with several Sandrock and two grey sandstone blocks. The upper also starts at the eastern window but dies out at a possible repair joint before the west window; it includes Sandrock and a new block of Banbury Marlstone Formation. The western window is unweathered oolite in the Decorative style, with a hood mould terminating in uncarved cubic blocks. It is enclosed in Blue Lias except for the blocks of Northampton Sand. The south

(priest's) door is typical Decorative style, with multiple roll mouldings built with shell debris oolite except for the stops; these are extremely weathered Northampton Sand, but the original king and queen heads can still be recognised. There is a roughly vertical join in the wall masonry between the door and eastern window on this south wall. The area enclosing this window appears to be an original wall of Blue Lias. Repaired areas with dressed stone courses occur above the window and also west of the vertical join. The second window has early Decorated Y tracery, and the mullions are fine-grained, thinly bedded dolomitic sandstone, Mansfield Stone. Although the style dates from c1300, this and the identical window on the north wall are early 19th century. The wall has two drip courses separated by two ashlar courses, the upper of oolite and Sandrock.

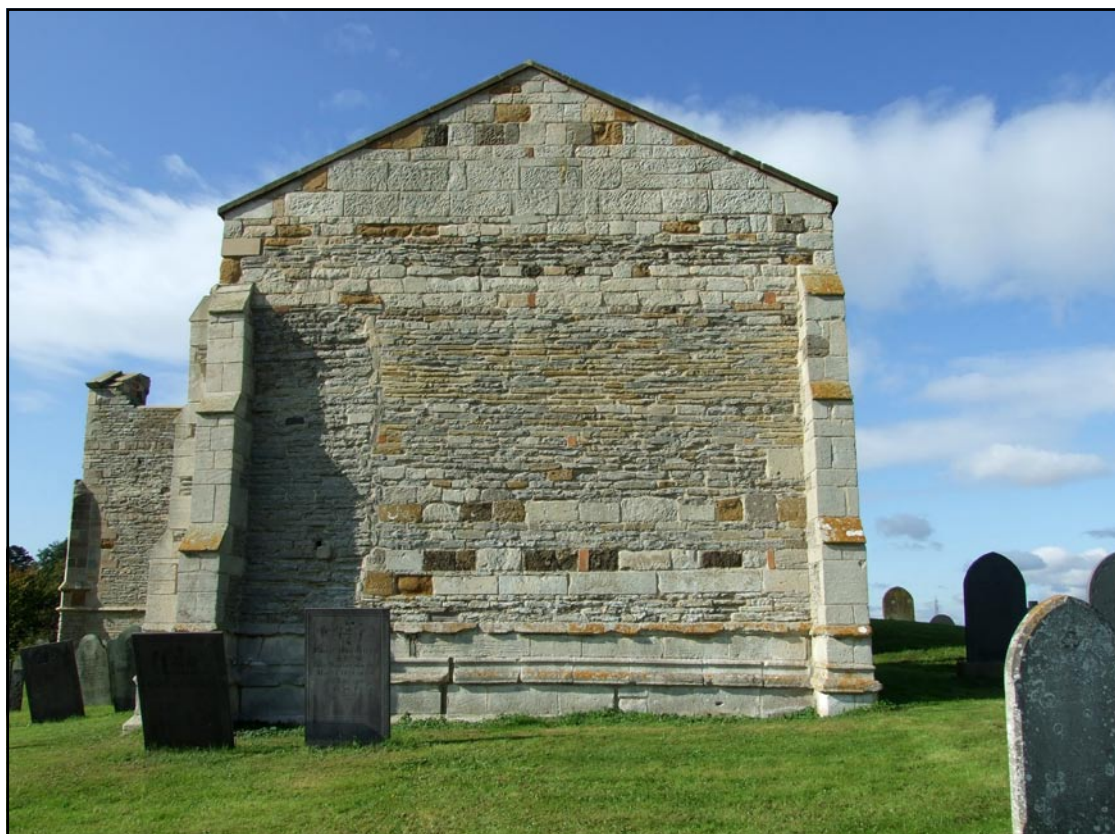
Figure 17. *The east wall, rebuilt without a window.*

The two drip courses continue on the external east wall, but the intermediate ashlar courses are oolite (Fig. 17). Surprisingly, the church lacks an east window. The southern masonry is almost entirely of Blue Lias. North of an irregular join, the wall above the drip course is Blue Lias, with three decorative strings made in a random selection of dressed oolite, Northampton Sand, Sandrock and Triassic sandstone. Three courses of mostly oolite occur above the buttresses. The triangular gable is of oolite with a few Sandrock blocks, and its basal course contains a rounded columnar block of oolite. The greater part of this wall has been rebuilt.
