Slope geomorphology and threshold slopes at Callow Bank, Hathersage, Derbyshire

Martin Cross

Abstract: Recognition of threshold and slope classes within a region indicates slope units where specific geomorphological processes are operating, and may be used to predict slope hazard areas. Using slope profile surveys and GIS techniques, analysis of slope form in the Callow Bank catchment near Hathersage identified characteristic and threshold slope angles. Geomorphological maps that adopt recognized characteristic and threshold slope classes allow an engineer or planner to identify slopes associated with particular hazardous processes.

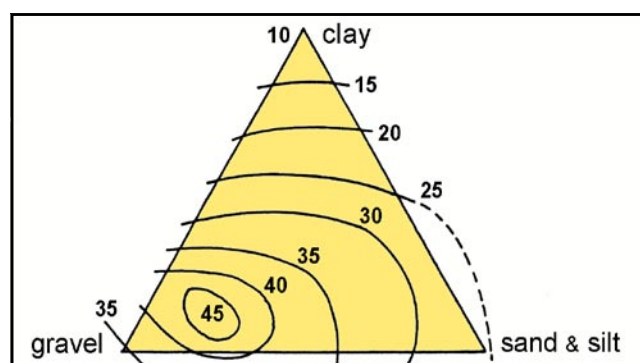
Figure 1. Angles of internal friction (in degrees) for different soil lithologies (after Kirkby, 1973).

Certain threshold slopes are more common, and relate to soil lithologies (Table 1). In the southern Pennines, straight segments on slopes at about 25° are considered to represent the angle of long-term stability for regolith, excluding clays (Carson & Petley, 1970). Breakdown of slope mantle during weathering determines reductions in the angle of internal friction of the soil (Cross, 2010); these affect the shear strength and cause changes in the stable slope angle (Fig. 1).

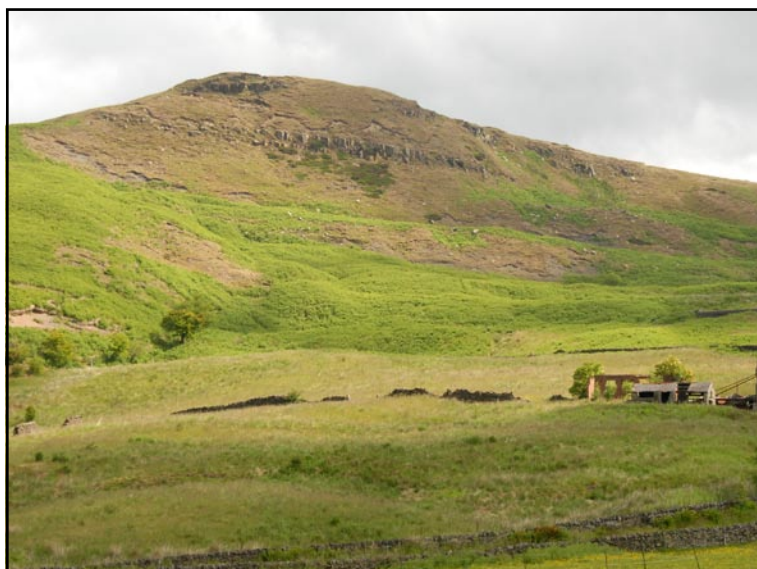
Figure 3. View up the length of the Callow Bank landslide, with the abandoned farm of Callow Bank on the right.

is the head scar of a landslide formed at the plateau edge in the lower leaf of the Chatsworth Grit, which is coarse grit and finer sandstone interbedded with about 20% of shale and mudstone (Fig. 3). Alternations of sandstones and sandy siltstones make up the lowest 18m of the lower leaf, and are exposed in the upper part of the slip face of the landslide. The thicker upper leaf of the Chatsworth Grit is the coarse-grained rock that forms Stannage Edge and the outliers of Higger Tor and Carl Wark to the south.

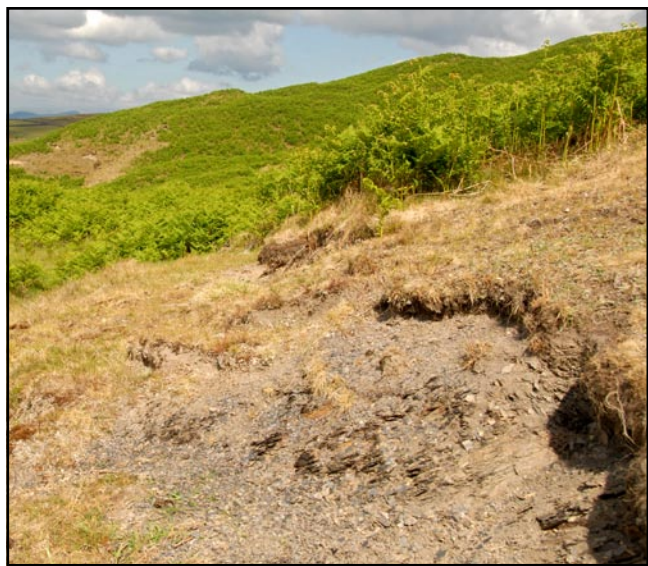
Figure 5. *Weathered shales in a rotated block within the upper landslide mass.*

siltstones, shales, sandy shales and thin sandstones (Fig. 4). The main landslide back scar is about 25m high, and rotational movements are deep-seated with moderate backward rotation of separate blocks (Fig. 5). The cause of failure was glacial erosion and valley over-steepening leaving the massive competent beds of sandstone exposed over weak shales. Rotational slides occur when maximum stress at the foot of the slope is transmitted by creep in the rocks within the slip zone (Petley and Allison, 1997; Rutter et al. 2003). The first slip movement probably developed from outward bulging and deformation at the slope foot, with retrogression taking place where tensional stresses caused movement outwards and downwards from the original slope (Petley, 2004). At least four major successive rotational movements have taken place. The deepest, and dominant, failure probably occurred on the black shale and seatearth that immediately overlie the Kinderscout Grit (which outcrops in the stream bed near the toe of the slide). Chemical and mechanical weathering of these shales may have induced deep-seated creep in the failure zone. At the foot of the landslide's back scar the main slide mass is characterised by topographic benches and depressions (Fig. 6). The lower section of the landslide, 300m below the back scar, has debris slide and mudslide components. This debris was more mobile, and moved by sliding outwards from the rotated units to create a low but uneven terrain as far as the tributary stream from Overstones, 500m from and 110m below the back scar (Fig. 4). Callow Bank Farm was built in 1720, and stands on the landslide debris slide. Ground movement, inevitable at its location, has distorted the buildings, which are now abandoned (Fig. 7).

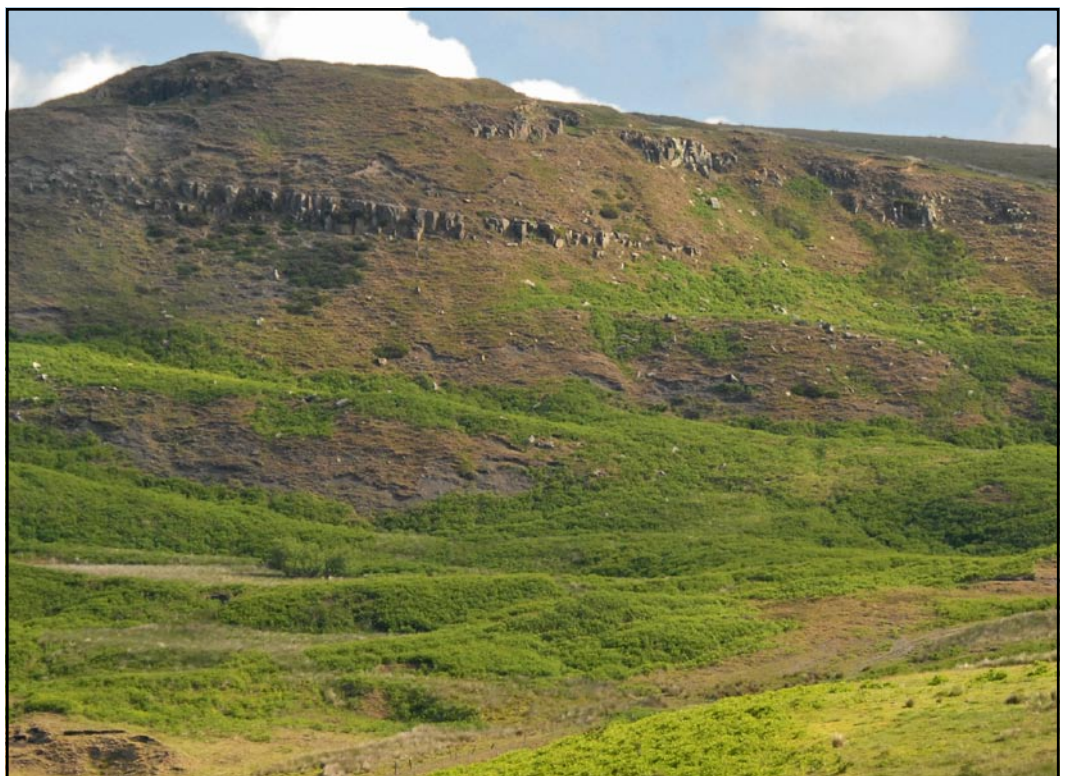
Figure 6. *Benches and depressions on the large landslide blocks directly beneath the back scar of Callow Bank.*

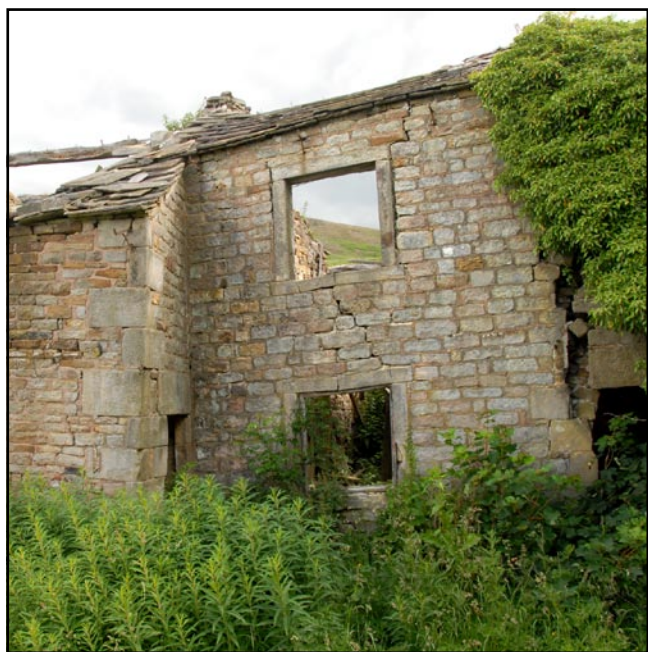
Figure 7. Distortion by ground movement of the old Callow Bank Farm, showing in the fracture through the stonework between the two window openings.

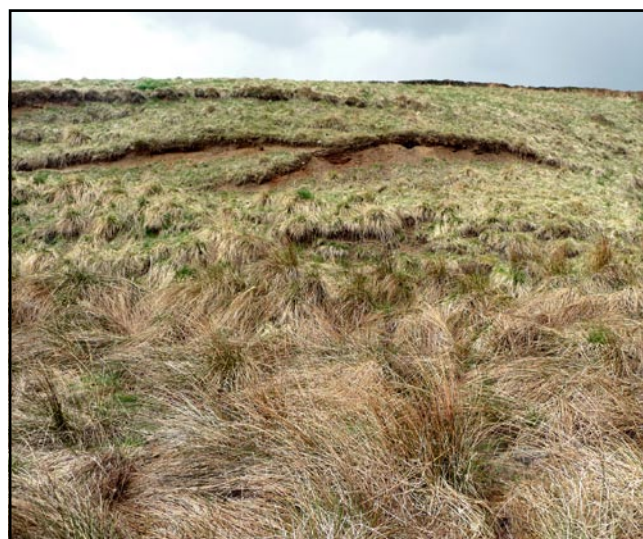
Figure 8. Small back scars above and behind shallow planar failures within the regolith.

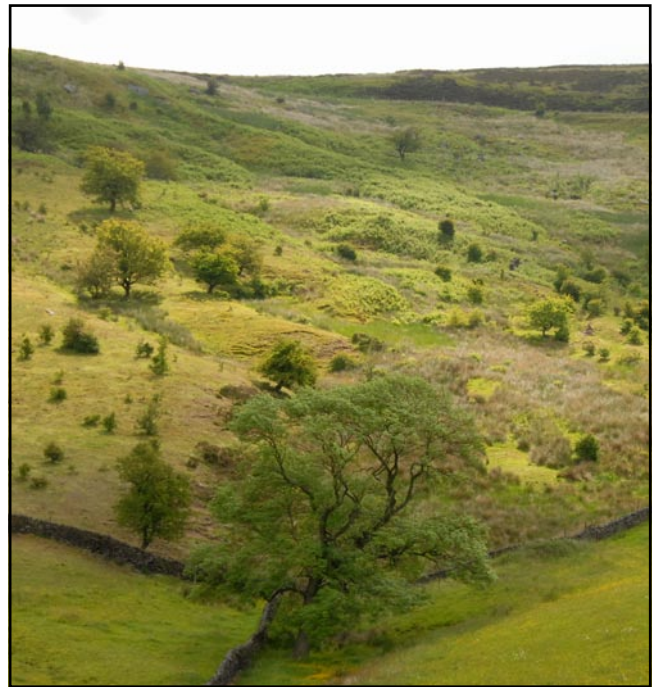
Figure 9. *The lower slopes of Higger Tor; with uneven ground on a regolith disturbed by solifluction movements and shallow mudflows.*

Shallow failures tend to be more localised, and are particularly influenced by changes in the ground water regime (Fig. 9). Until drained, they may be highly susceptible to further movement if their temporary equilibrium is disturbed. The recognition of these areas is important to engineering projects on slopes. Many of the foot-slope units in the southern Pennines are covered with landslide and solifluction debris that may be up to 20m thick with numerous slip surfaces.

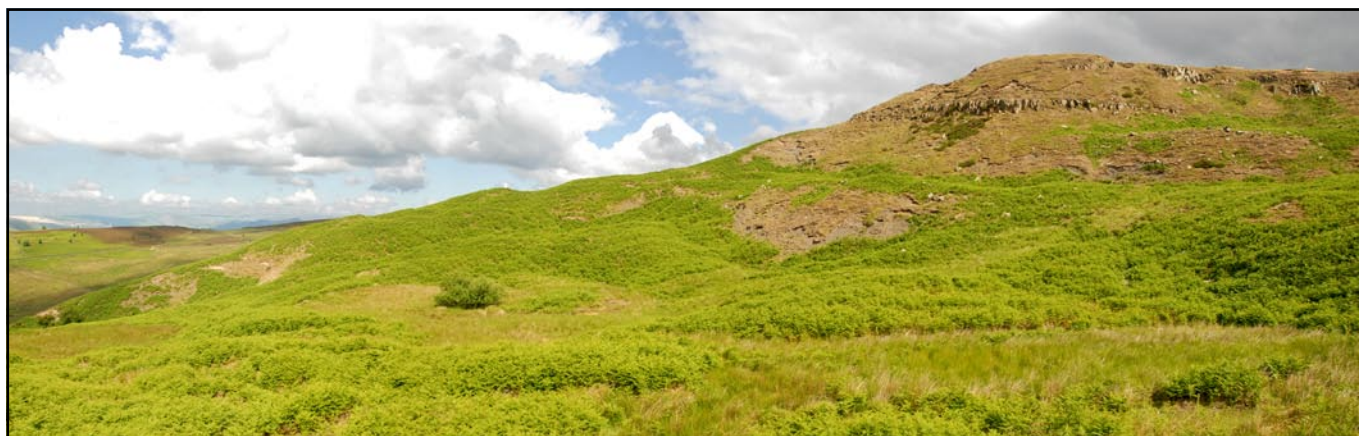
Figure 10. Broken and disturbed ground at the upper end of the Callow Bank landslide.
