# Old mines and new sinkholes along the Hucklow Edge vein, Derbyshire

John Hunter

**Abstract:** A major, near-vertical mineral vein hosted by faulted Lower Carboniferous limestone is concealed beneath the Namurian mudstone forming the southern slope of Hucklow and Eyam Edges. It has been mined underground from numerous localities in several phases during a period of three centuries. The depth of working increased progressively as more options became available to drain water out of the mines. Prior to the 20th century, these operations were limited to the selective extraction of higher-grade zones of galena. Miners left the gangue minerals largely intact, albeit honeycombed with a network of narrow tunnels and stopes. The overlying mudstone was also penetrated by shafts and tunnels. The modern Milldam Mine recovers the unworked, in-situ vein minerals (mainly fluorite, barite and calcite) by open stoping of the vein across its full width. Mined-out voids are backfilled with waste rock to provide long-term ground stability. The legacy of historical underground mining and the particular local geology has created situations where unsupported, weak roof zones above open cavities are vu

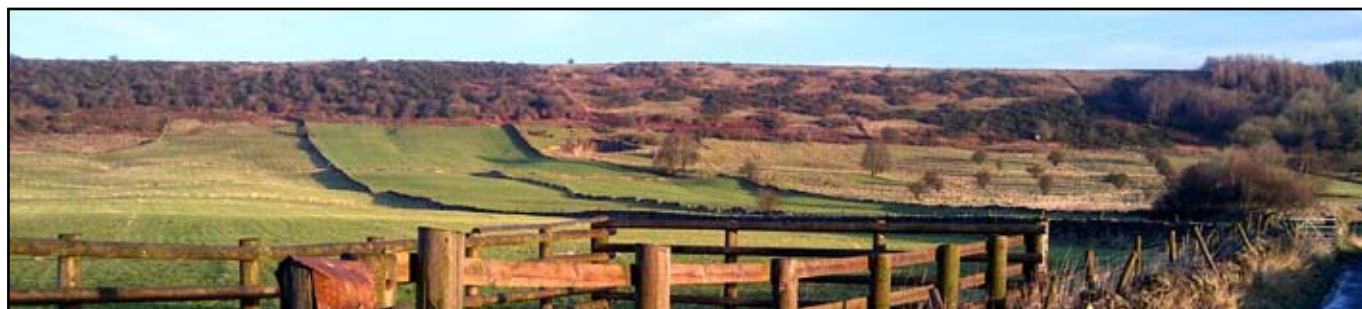
*Figure 1. Hucklow Edge, viewed from the south, with the 2013 sinkhole in the centre on the lower slope of the edge (photo: PDNPA).*

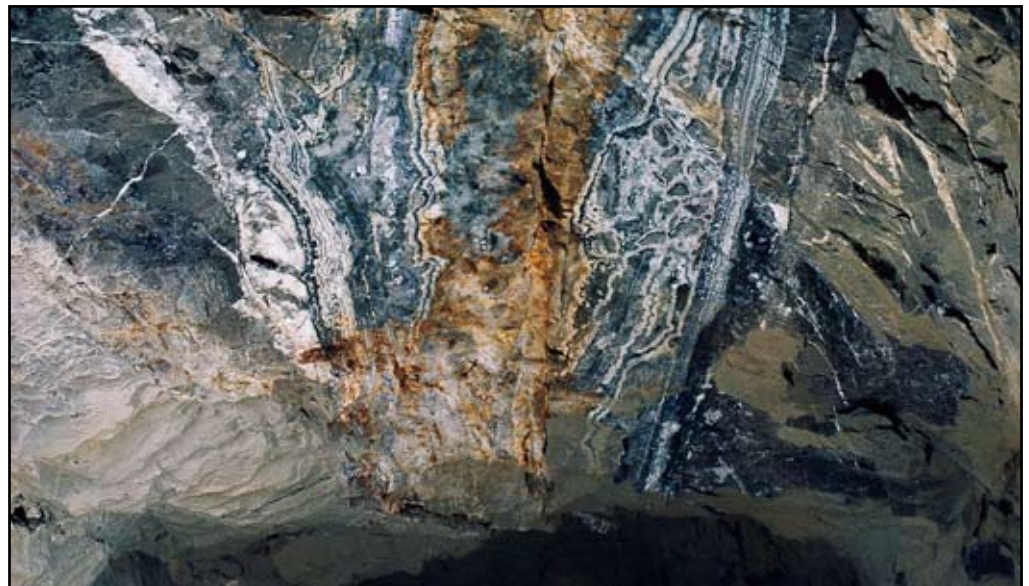
**Figure 4.** Mineral vein exposed in the roof of a sub-level in Milldam Mine; it consists of banded and brecciated fluorite with a central core of late-stage calcite and barite (photo: Paul Deakin).

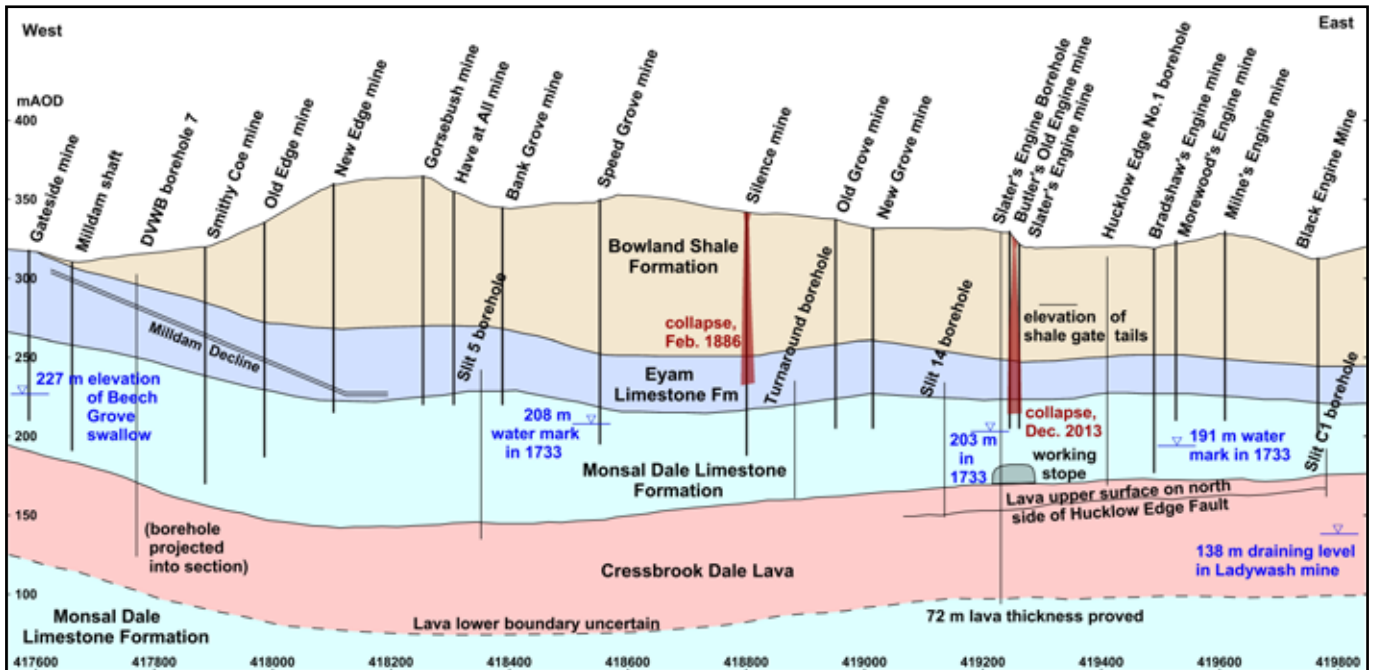
**Figure 5.** Longitudinal section along the line of the Hucklow Edge mineral vein; most shaft depths are uncertain, and details of the mine workings are omitted. Vertical scale exaggeration = 2.66.

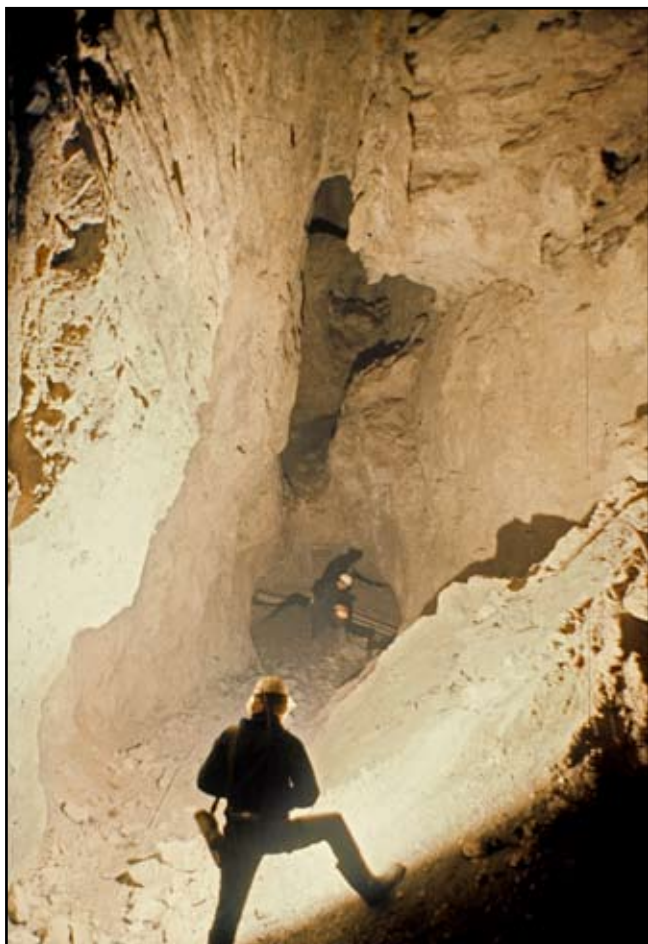
**Figure 6.** Worked-out stope on the Old Edge vein in Ladywash Mine, typical of the earlier phases of 'in-vein' workings.

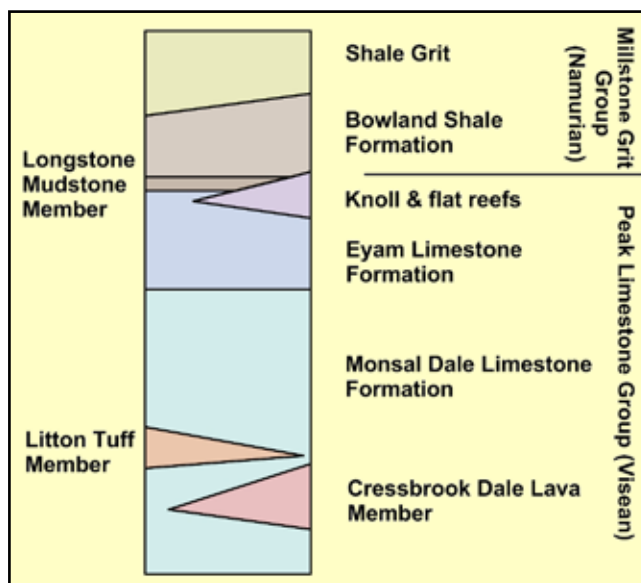
**Figure 7.** Lithostratigraphy for the Hucklow Edge area.

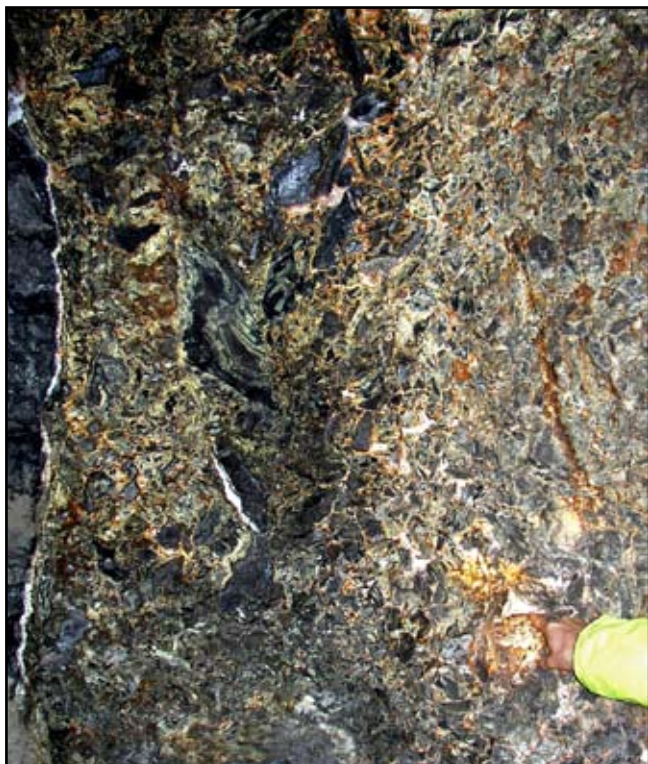
**Figure 8.** Brecciated mudstone associated with Hucklow Edge fault, exposed in the highest sub-level in Milldam Mine.

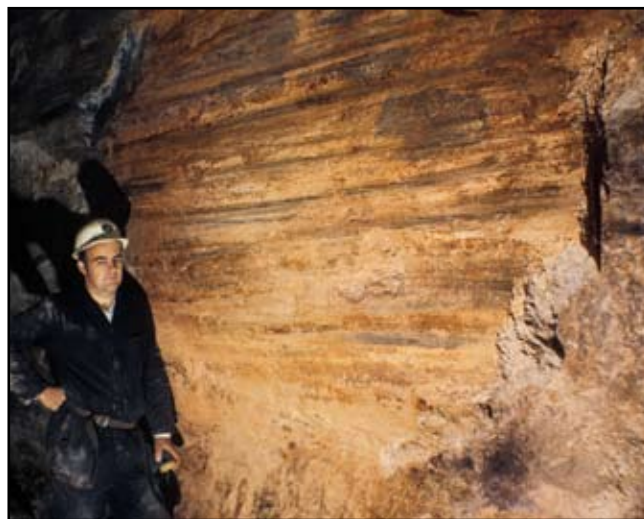
**Figure 9.** Slickensides on a stope wall in the Ladywash Mine.

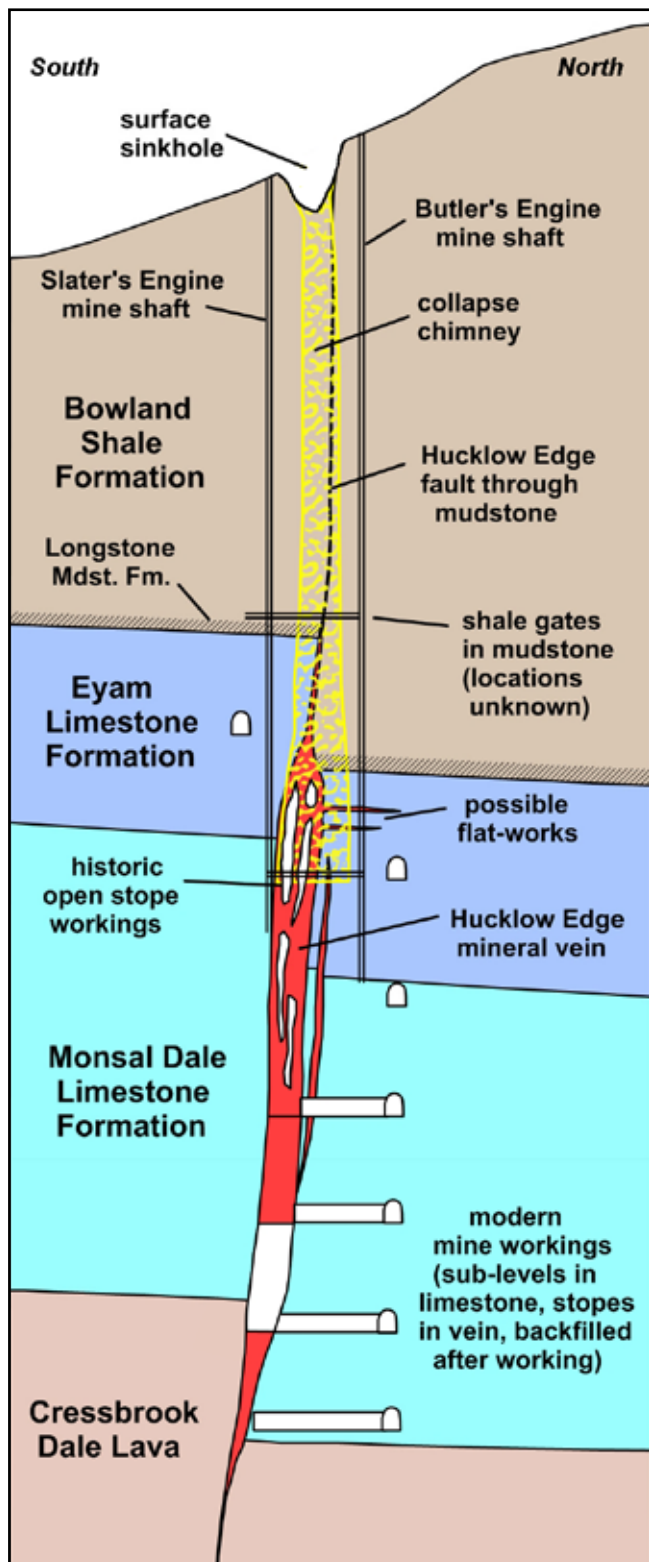
**Figure 10.** Transverse section through the Hucklow Edge mineral vein, with a conceptual model of features probably associated with the chimney collapse near Slater's Engine Mine; the height on the north side is about 250 m.

The dimensions of the previously existing cavity into which the mudstone rubble collapsed are unknown, but it is possible that the chimney above it has a wide, elongated base aligned over an old open vein stope or flat (or both), tapering upwards to a narrower circular shape, before flaring out to the sinkhole in the shape of an inverted open cone formed in weathered mudstone.

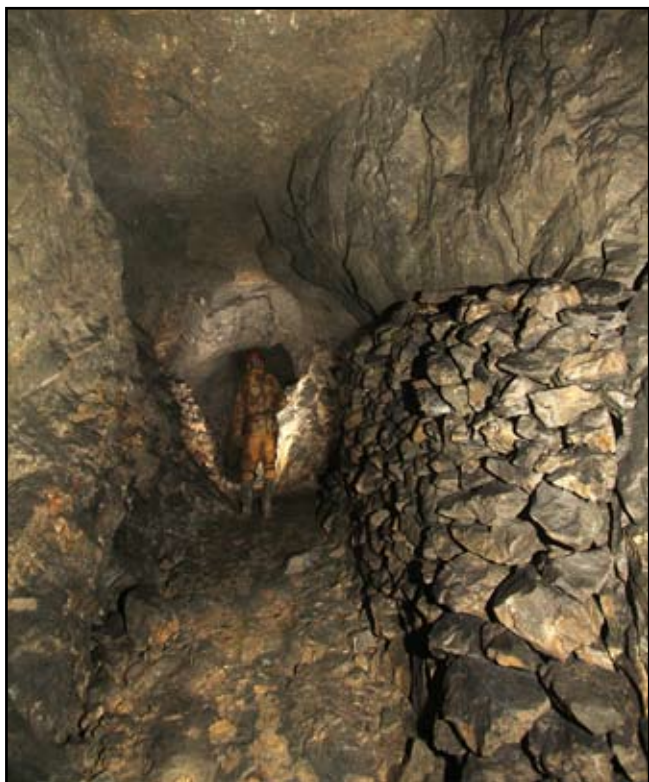
**Figure 11.** Typical gallery, with stacked 'deads' left by the 'old man' in the upper parts of the vein (photo: Rob Eavis).

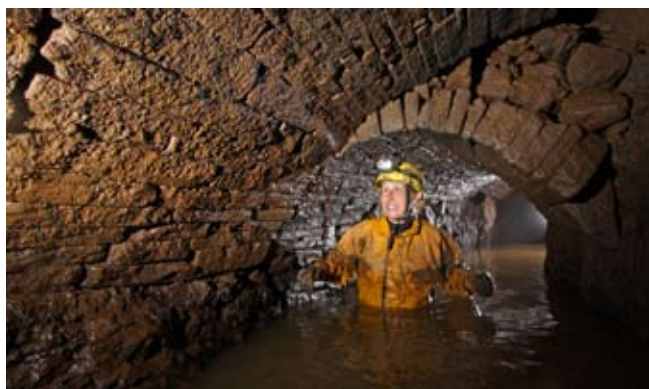
**Figure 12.** Stone arching that supports the roof in Morewood Sough, west of Stoney Middleton (photo: Rob Eavis).

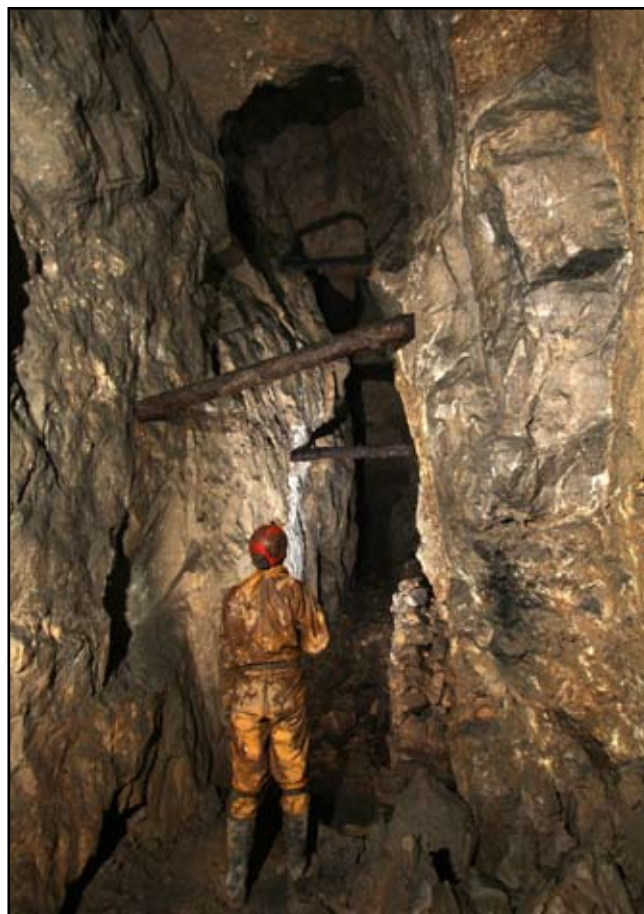
*Figure 13. Timber stemples in an abandoned stope within the higher part of the vein (photo: Rob Eavis).*

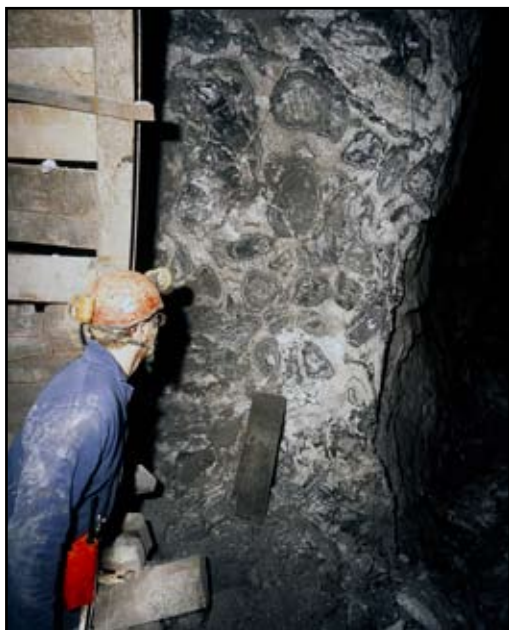
**Figure 14.** A cross-cut slit into an open stope in Milldam Mine, with brecciated fluorite in the stope wall (photo: Paul Deakin).

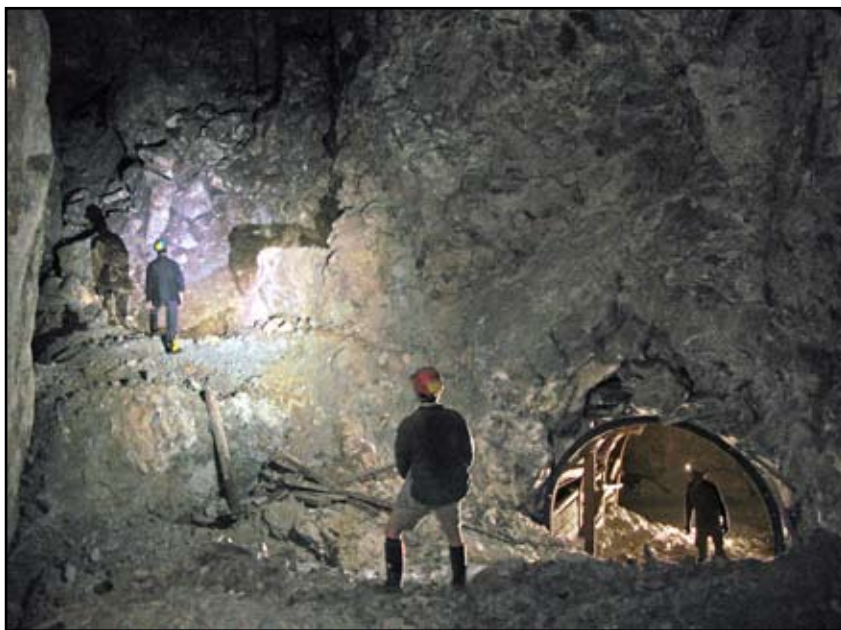
**Figure 15.** A short slit into a large stope that was worked many years ago in Milldam Mine (photo: Rob Eavis).

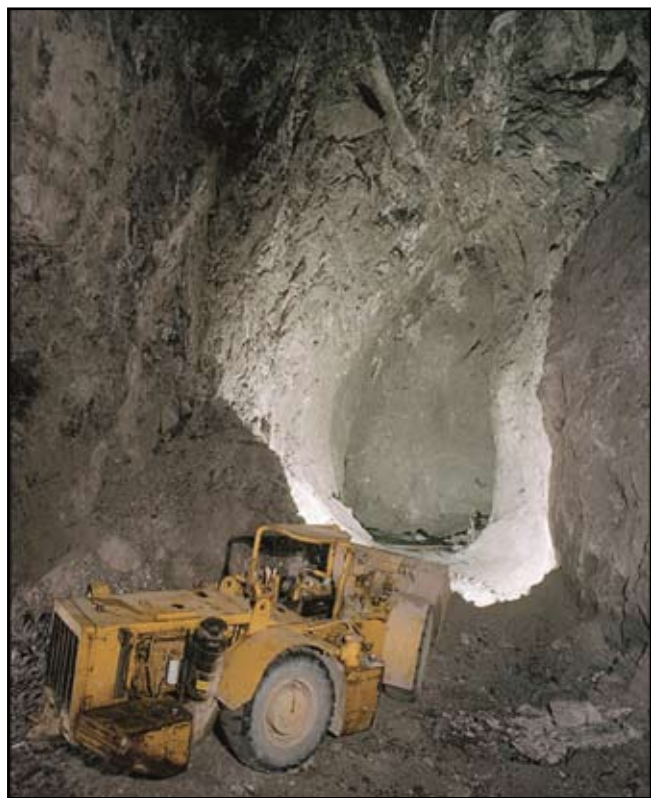
**Figure 16.** A large stope in Milldam Mine, worked 'in vein' before slits were used to reach the stopes(photo: Paul Deakin).

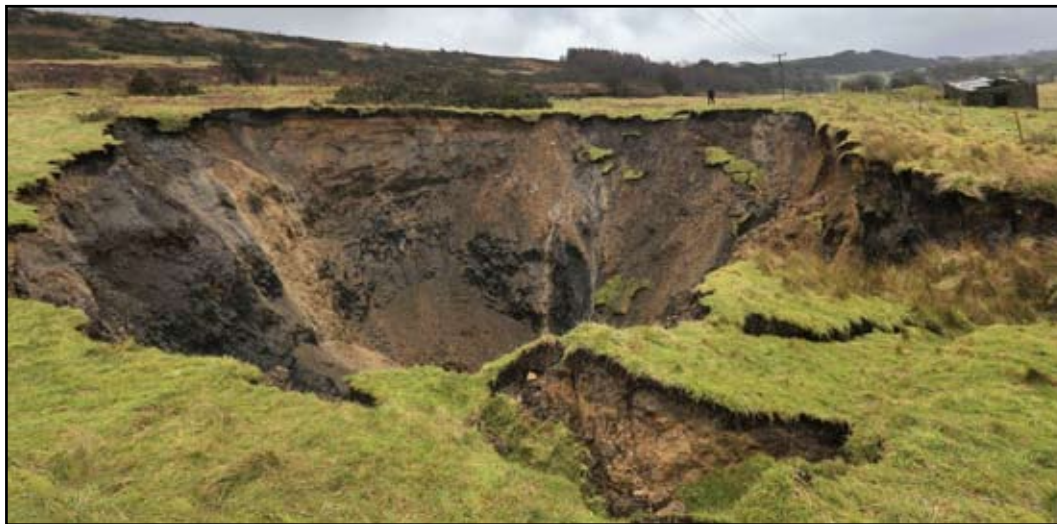
**Figure 17.** The sinkhole that developed over the chimney collapse in December 2013 (photo: The Independent).

The surface area of the sinkhole was measured as 1150 m<sup>2</sup> and its maximum depth was 19 m; giving it a volume of about 7280 m<sup>3</sup>. A bulking factor around 35% may be expected in broken material falling out of the roof of a collapsed underground void; this means that upwards failure reaches only about three times the original void height before it stabilises when the fallen debris meets the roof. For a collapse-chimney to propagate through about 100 m of cover and also to leave a surface crater exceeding 7000 m<sup>3</sup> suggests that some of the historic mine workings may be larger than previously thought. Slater's Engine shaft, located close to the collapse crater, was unaffected by the disturbance and it remains open down to a known blockage at a depth of 54m.

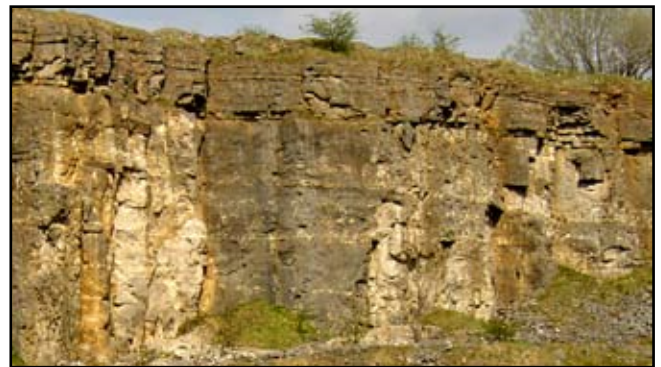
**Figure 18.** Thin-bedded Eyam Limestone overlying the more massive Monsal Dale Limestone, exposed in Furness Quarry, above Stoney Middleton.

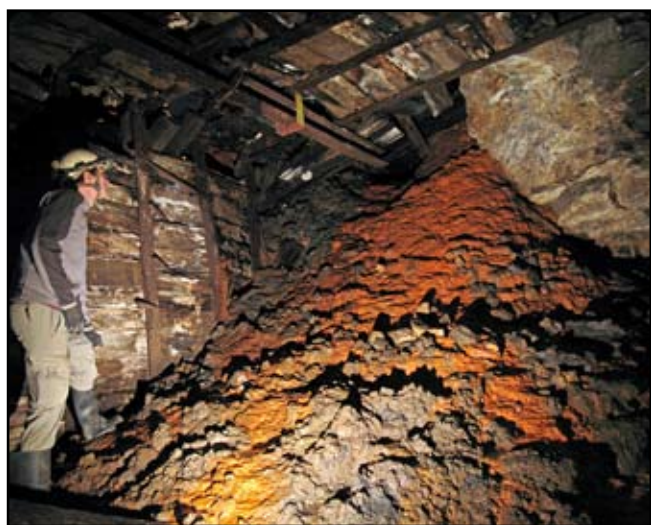
**Figure 19.** A run-in of mud and debris where a high-level cross-cut within an early phase of the mine had encountered even older workings left by the 'old man' (photo: Rob Eavis).

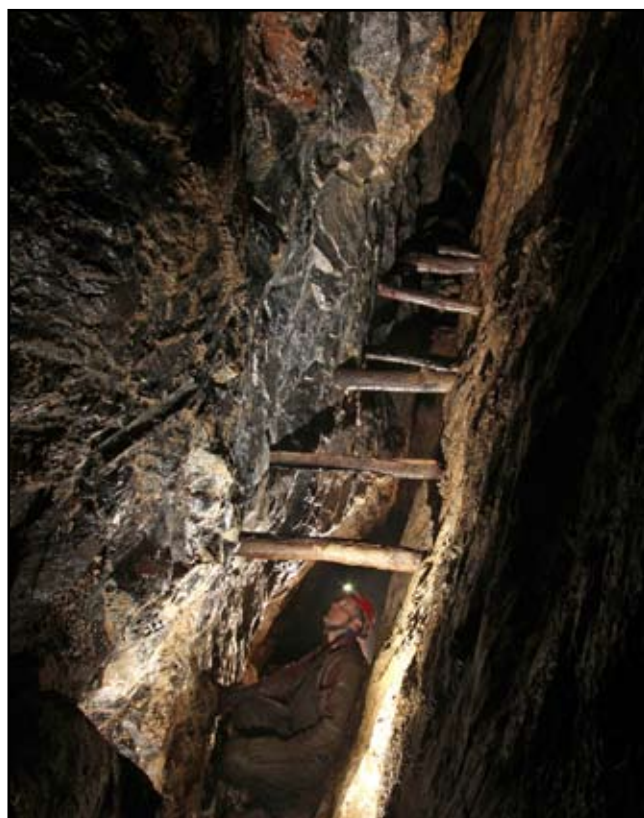
**Figure 20.** A line of stemples across a slope in "old man" workings in a higher part of the vein (photo: Rob Eavis).

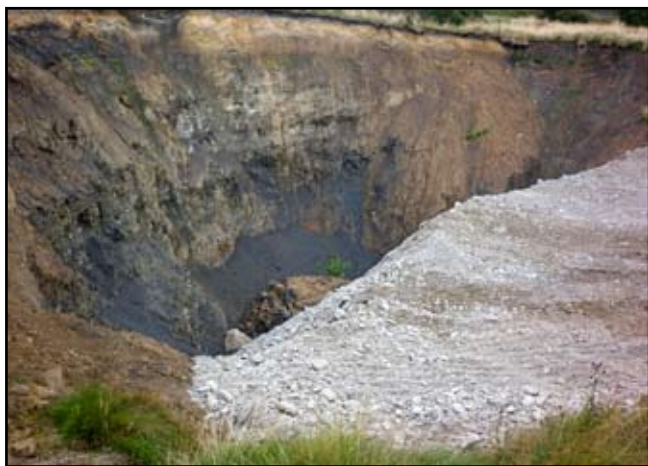
**Figure 21.** Backfilling the sinkhole in 2014, when the Bowland Shale mudrocks were exposed on the left side (photo: PDNPA).
