Fault Reactivation Induced by Mining in the East Midlands

Laurance J. Donnelly

Abstract: Mining-induced fault reactivation has been observed at several localities throughout the East Midlands, between 1930 and 2000. The generation of new fault scarps has caused widespread damage to structures and land. These scarps are distinct, reach over a metre high and extend for several hundreds of metres at outcrop. In areas of moderate relief, such as on the Permo-Triassic escarpments, natural process of cambering and valley bulging may be exacerbated by mining subsidence. Recent field observations suggest that some faults may undergo renewed phases of reactivation, several years after mining has been abandoned, probably due to minewater rebound, although this is difficult to prove at some sites. Some of the engineering problems and environmental geohazards associated with fault reactivation are outlined with reference to case examples.

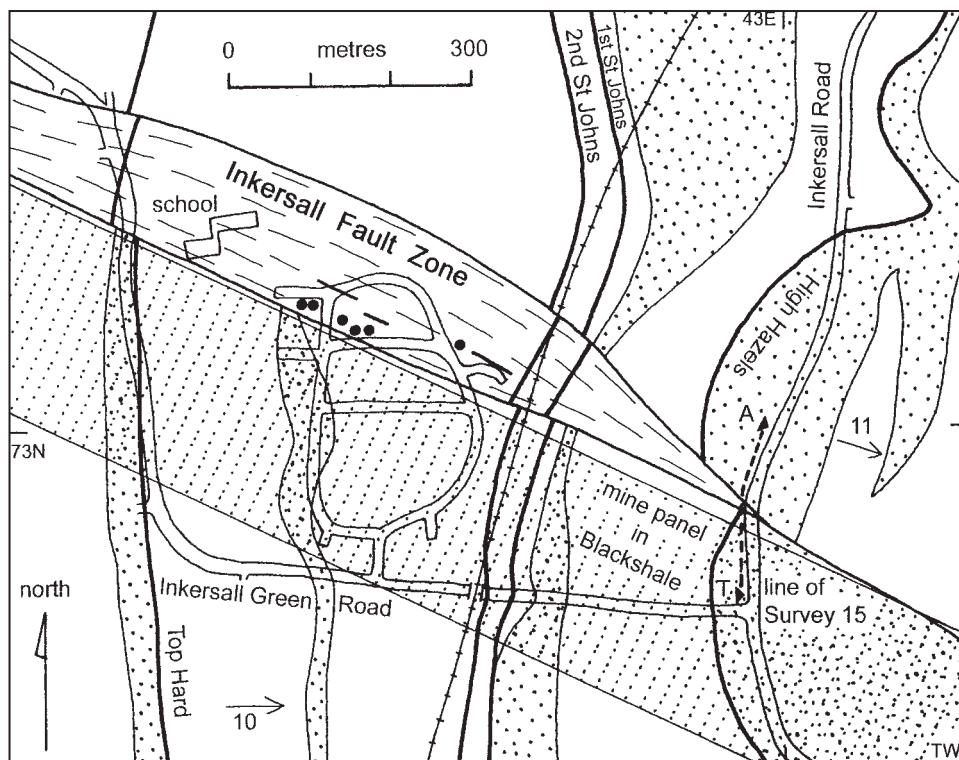
Figure 2. Geological map of the Inkersall Fault at Inkersall Green. Coal seams are named, sandstone outcrops are stippled, and the rest of the outcrop is mainly mudstone of the Coal Measures. The outer limits of the fault zone are as recorded on the BGS map; the short fault lines marked within the zone have been reactivated to create scarps. Solid circles indicate the sites of buildings that have been demolished.

This fault crops out in the Middle Coal Measures, near to the villages of Staveley and Inkersall, 6km east of Chesterfield. The fault zone is bounded by two sub-parallel fractures separated by a distance of a few hundred metres (Fig. 2). It is a steep normal fault with an apparent sinistral component of slip, dipping at 74°NE, with a throw of 30-50m. At least six coal seams have been extracted close to, and on both sides of, the Inkersall Fault.

The earliest records of fault reactivation were during the working of the Deep Hard seam in the 1950s, at depths of around 28m below Inkersall. Further phases of reactivation occurred in 1985, during the working of the Piper seam, at about 300m depth, from Markham colliery. This created surface movements that caused severe damage to property in the Inkersall Green housing estate, and generated fault scarps (Fig. 3) that were locally over 1.5m high. Eight houses (Fig. 2) were severely

damaged by fault movements and were subsequently demolished; since the mining has ceased under Inkersall, new houses have been placed on some of these sites. The school was also severely affected and there was extensive damage to roads, walls, pavements, and utilities. Yet more houses on the fault zone were badly damaged or tilted and remained unoccupied for several years. Houses outside the fault zone suffered only the modest damage, as was normal for mining subsidence on unfaulted ground.
