RATES OF EROSION IN THE CATCHMENT AREA OF CROPSTON RESERVOIR,
CHARNWOOD FOREST, LEICESTERSHIRE

W.A. Cummins and H.R. Potter

Summary

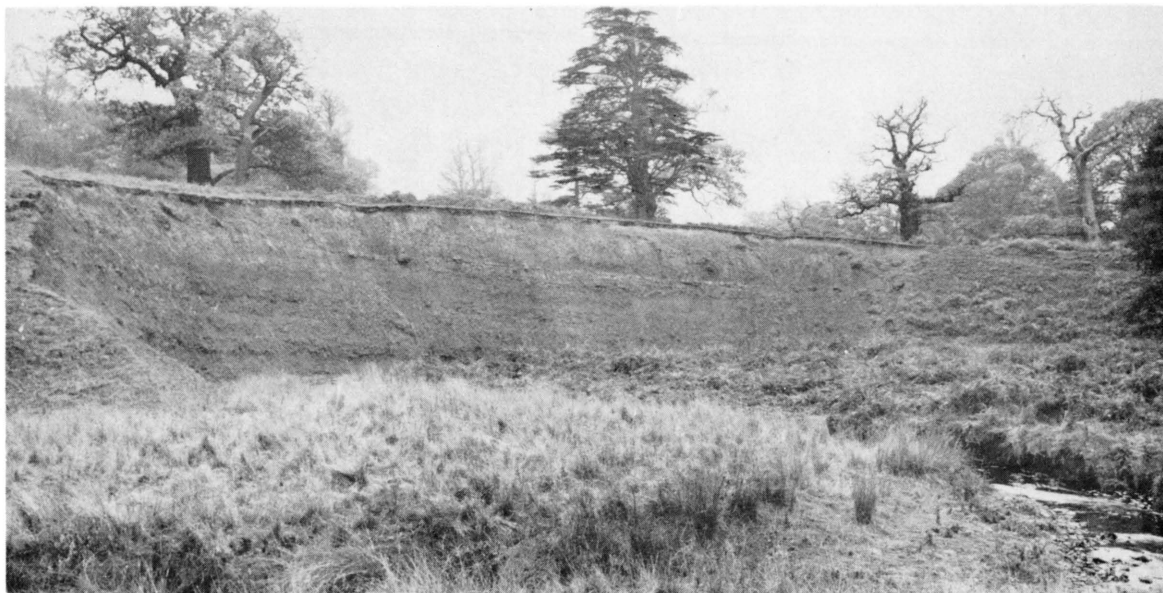
Top: General view of the Keuper Marl cliff in Bradgate Park, as seen from the north. The main cliff of fresh Keuper Marl is slightly darker than the weathered zone above.

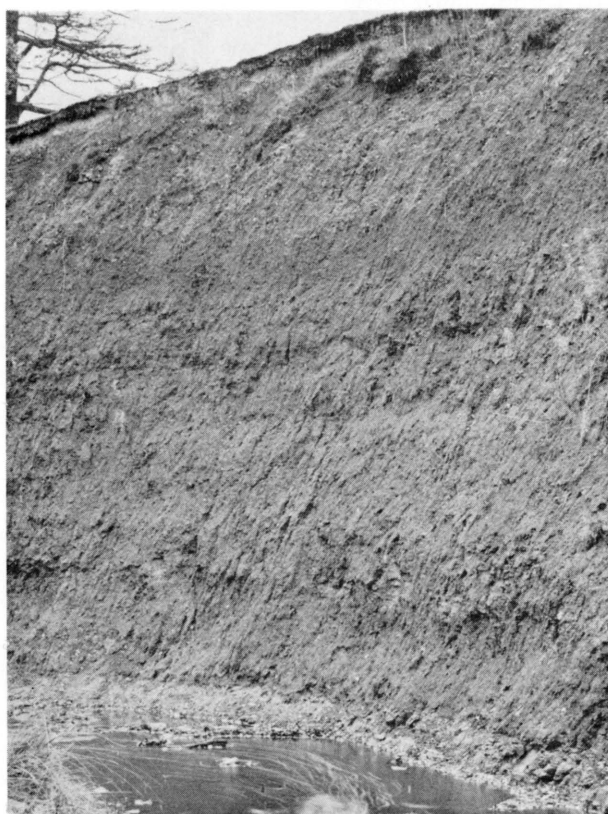
Lower left: The cliff face. The prominent drag marks are caused by masses of wet sediment and turf sliding down the cliff face. Note the detached masses of turf near the top of the cliff. The scree at the foot of the cliff has been entirely removed by recent erosion.
