HOLIDAY GEOLOGY

Ground subsidence in Mexico City

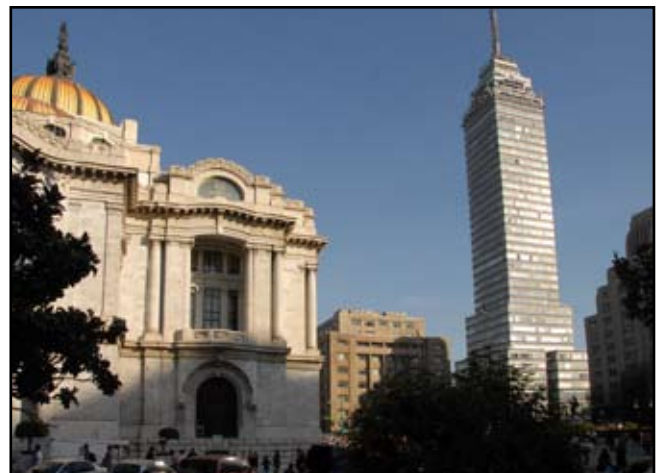
The Torre Latinoamericana rising beyond the profile of a corner of the Palacio de Bellas Artes.

Probably the winner in the subsidence stakes is still the Palacio de Bellas Artes, a huge marble edifice that is essentially the national museum at the eastern end of the Alameda. When its construction started in 1904, subsidence was anticipated, so it was placed on a thick concrete raft (though this significantly added to the total weight of the structure). It has subsided more than three metres below street level, and is still going down. The current entrance is into what was once the first floor, and the original entrance hall is now the basement.

A clever foundation design was employed in building the Torre Latinoamericana, a tall office building just across the street intersection from the Palacio de Bellas Artes. Basements reduce its load, but it also has deep piles. These were taken down only to an intermediate sand horizon. The intention was that loading compaction of the clay beneath the sand would match the de-watering compaction of the clay above, thereby keeping the building's entrance at street level. The plan has almost succeeded, but not quite, as the adjacent pavement is now distorted where it has subsided just a little faster than the building. Along with the shear cracks where an adjacent building has subsided more on its un-piled raft, this buckled pavement makes another worthwhile location on a geological walking tour of Mexico City's remarkable ground subsidence.

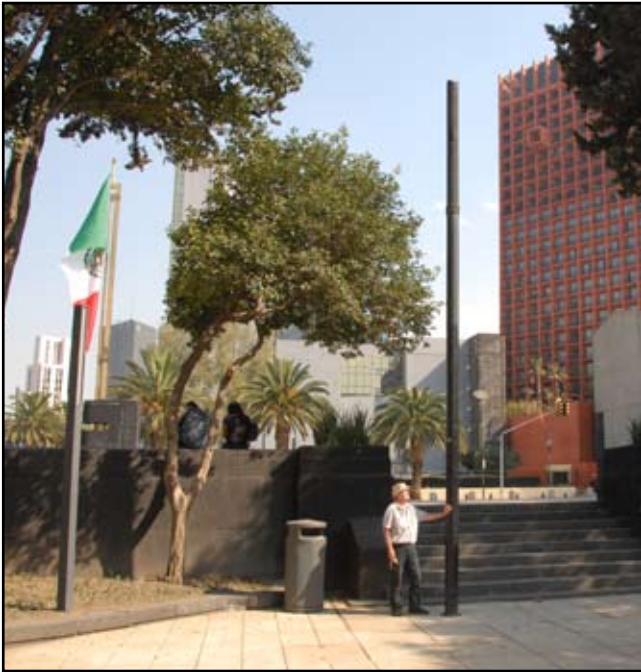
The protruding well casing in Plaza de la Republica.

The ground surface has subsided beneath the whole city centre, taking all the roads, buildings, infrastructure and services with it. Everything that is, except the well casings. These rigid steel tubes have not moved, because they are effectively founded in the sands around 100 metres down, where they are below most of the compacting clays. So the adjacent ground has subsided, and has left them protruding from the surface. The classic example is a single, old well casing that has been left untouched, without its protruding top being repeatedly cut off. It stands near the southeastern corner of the Plaza de la Republica, the second most important square in Mexico City, a short walk west of

the Alameda. This unique well casing just looks like an anonymous street pole, more than seven metres tall, and most people pass by without knowing the story behind it, as an explanation board is sadly lacking. But it is a geological classic, as one of the world's most spectacular demonstrations of ground subsidence. And it is still getting taller. Continuing ground movement is indicated by the unpainted bit which was below ground level when it was last painted. Controls on water abstraction have now reduced the city's rate of subsidence, but have not stopped it.

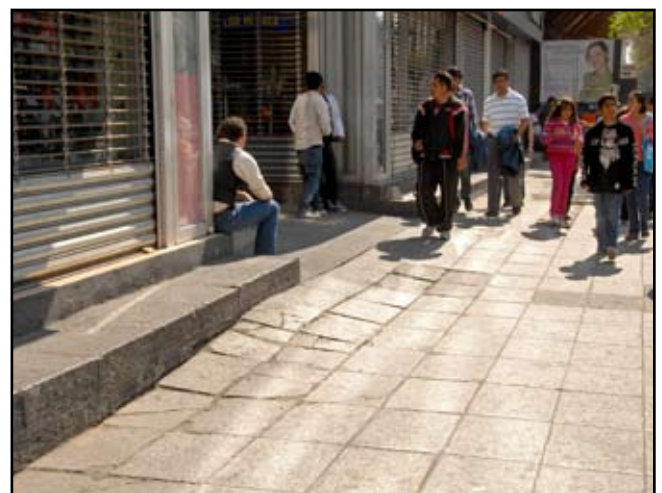
The subsided and distorted street pavement alongside the relatively stable Torre Latinoamericana.
